WEST regular in-vessel inspections with the Articulated Inspection Arm robot

V. Bruno^{*}, L. Allegretti^a, A. Barbuti^a, S. Bremond^a, Y. Cheng^b, C. Dechelle^a, N. Dufour^a, H. Feng^b, L. Gargiulo^a, D. Mouyon^a, B. Santraine^a, S. Shi^b, Y. Song^b, Y. Sun^b, E. Villedieu^a, B. Vincent^a, L. Zheng^b

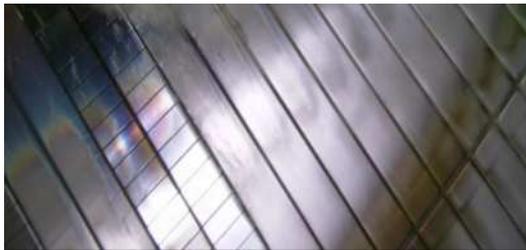
Fig. 14 - Shadows observed after the ITER like W monobloc

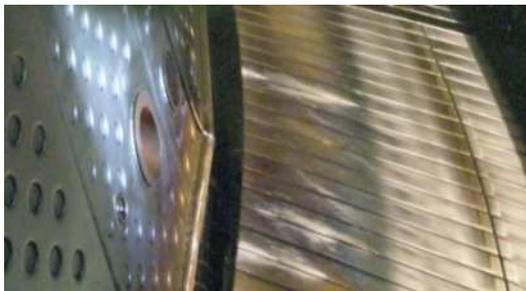
Fig. 15 - Image of WEST bottom divertor

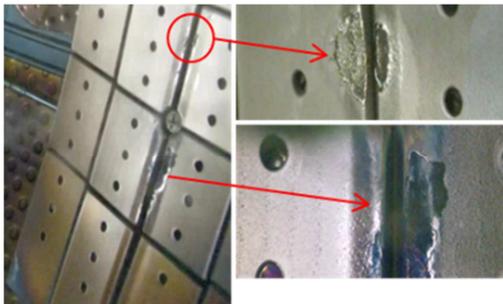
Fig. 16 - Runaways impacts on WEST outer limiter after the 1st campaign. Damaged tiles have been swapped and no further damage was observed after runaways avoidance schemes were developed
