Evaluation of total ionizing dose effects on commercial FRAMs

Mariem Slimani, Jean-Marc Armani, Rémi Gaillard

Evaluation of Total Ionizing Dose Effects on Commercial FRAM

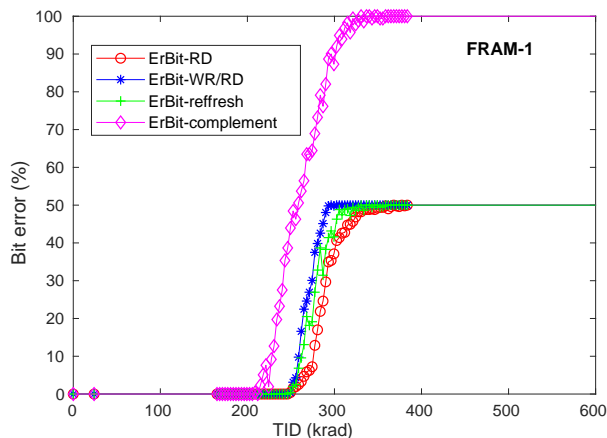
Total ionizing dose testing has shown very different results between FRAM references. Fig. 2 and Fig. 3 show the percentage of bit errors in the memory chips as a function of the deposited dose for FRAM-1 and FRAM-2, respectively. The reference FRAM-1 has maintained the complete functionality up to 200 krad, while radiation hardness level of FRAM-2 is 17 krad. This huge difference can be explained either by the use of different CMOS technology process for the implementation of the peripheral CMOS circuitries (sense amplifier, decoders...) and the nMOS transistors of the memory cell [13] or by the use of different bit cells architectures (1T/1C vs 2T/2C) .

All read data were stucked at zero at 300 krad for FRAM-1 and at 20 krad for FRAM-2. As half of the theoretical test pattern bits are at logic value '0' and the other half at logic value '1', the bit errors ($ErBit-RD$, $ErBit-WR/RD$ and $ErBit-reffresh$) have a maximum value of 50%. However, trying to write the complement of read data reveals the stuck-at faults problem. Actually, the bit errors in the read only part of the memory expose retention problem

On the other hand, FRAM-1 shows an increase on the number of erroneous bits as the deposited dose increases. This can be assigned either to a damage on the peripheral circuitries including row decoder, column decoder, sense amplifier or plate line selectors, where clusters of bit errors are expected, or to a failure problem at the memory cell. Actually, memory cell degradation can be ascribed to one of the following problems :

The data collected from the test of FRAM-1 show that erroneous bits belong to different words, which dismiss an address error problem. Moreover, the first observed errors for FRAM-1 appear when trying to write the complement of read data, namely we had failed to change the value of some bits initially

Fig. 2: Bit error versus deposited dose for FRAM-1.

programmed at the logic value '0' to the logic value '1'. This suggests first a correlation between the initial programmed value and the stuck-at error and second that bits initially programmed at the logic value '0' are more sensitive to ionizing radiation. This behavior can be explained by the photo induced fatigue-like of the ferroelectric material which reduces the hysteresis loop of ferroelectric capacitor, as explained previously. However, we do not exclude the scenario of a reading problem due to the leakage current increase in the NMOS pass transistor, as current measurements show that the increase of leakage current is followed by the presence of bit errors.

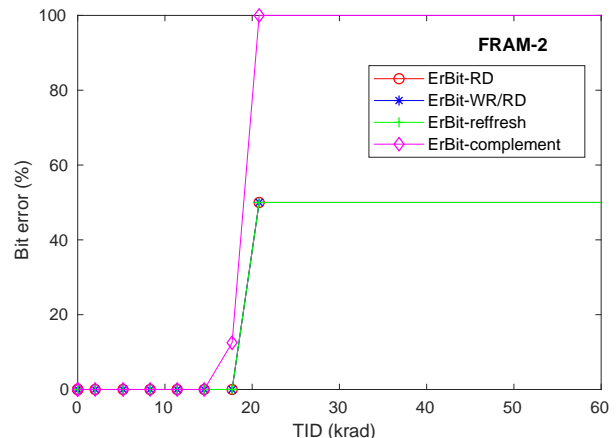
The results of FRAM-2 show a sudden functional failure where all read data are stuck-at zero. This failure is most probably due to a problem at the peripheral CMOS circuitries shared by all memory bit cells, such as control or I/O circuitries.

Fig. 3: Bit error versus deposited dose for FRAM-2.

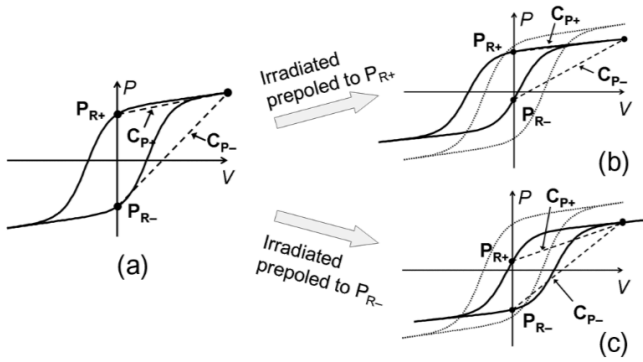
- Fatigue-like or/and imprint-like phenomena affecting the remanent polarization (PR+, PR-) of the ferroelectric capacitor under irradiations. The fatigue-like phenomenon induces a decrease in the hysteresis loop width due to the charge trapping in the ferroelectric volume

while the imprint-like phenomenon results in a shift in the hysteresis loop from the right to the left or from the left to the right depending on the pre-poled state of the capacitor, as shown in Fig. 4 [14]. These shifts influence the charge density of the remanent polarization becoming very close and can not be distinguished any more.

Fig. 4: Radiation effects on the hysteresis loop (a) fresh ferroelectric hysteresis loop (b) shift to the left of the hysteresis loop after irradiation of a capacitor pre-poled to P_{R+} (solid = irradiated, dotted = fresh) (c) shift to the right of the hysteresis loop after irradiation of a capacitor pre-poled to P_{R-} (solid = irradiated, dotted = fresh).

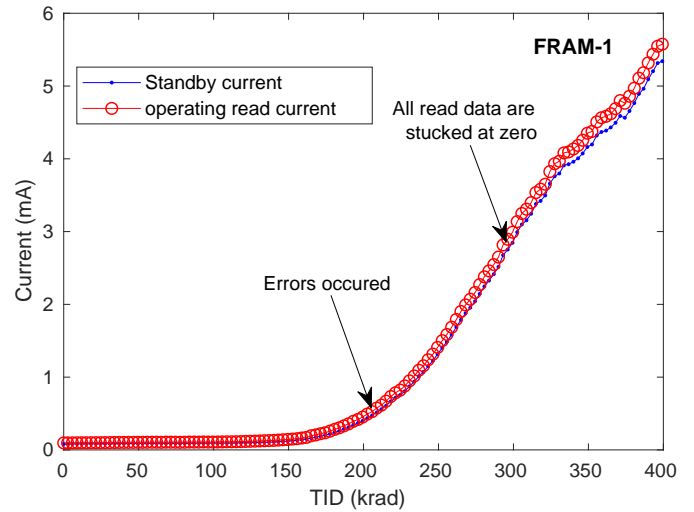
Fig. 5 and Fig. 6 show TID effects on dynamic and standby currents of the studied FRAMs. Before irradiation, FRAM-2 has the lowest standby current in the order of $70 \mu\text{A}$. This current had rapidly increased with the deposited dose. When it reached 16 times its initial value ($\approx 1 \text{ mA}$), the correspond-

Fig. 5: TID effects on dynamic and standby currents of FRAM-1.

ing memory failed to read data. Like FRAM-2, the supply current of FRAM-1 had steadily increased but with much smaller increments. Errors started to occur when the current reached 1.3 mA and the data bits were all stuck-at 0 at a supply current of 4.5 mA. For both FRAM-1 and FRAM-2, the operating read current follows the trend of standby current which is explained by the fact that TID increases mainly leakage currents.

has drastically decreased (68 mA after 3 days of annealing and 5 mA after 1 month of annealing versus 100 mA at the end of irradiation), all read data bits were still stucked-at zero. On the other hand, FRAM-1 has undergone a gradual annealing where its leakage current has regained a small value (1 mA after 3 days of annealing and 0.33 mA after 1 month of annealing) and all data bits were correctly written/read just after 3 days of annealing.

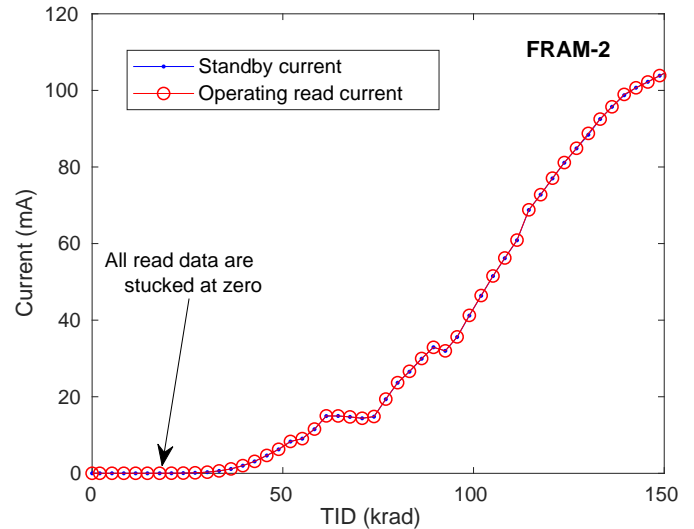
Fig. 6: TID effects on dynamic and standby currents of FRAM-2.

Annealing tests were performed at room temperature. The results show no significant annealing effect on FRAM-2. Although its leakage current
