Polishing-induced contamination of fused silica optics and laser induced damage density at 351 nm

Jerome Neauport, L. Lamagnere, H. Bercegol, F. Pilon, J.-C. Birolleau

Abstract: In this paper we study the effect of contamination induced by fabrication process on laser damage density of fused silica polished parts at 351 nm in nanosecond regime. We show, owing to recent developments of our raster scan metrology, that a good correlation exists between damage density and concentration of certain contaminants for the considered parts.

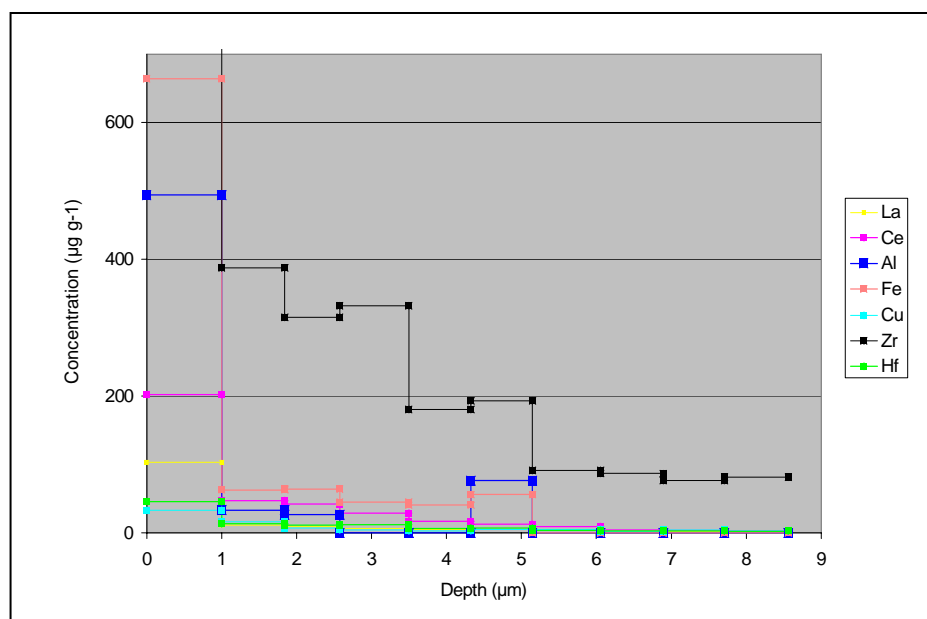
Fig. 3. Depth profiles of impurities concentrations for sample B2

This analytical procedure allows us to evaluate concentrations of impurities as a function of depth. Figure 3 illustrates the surface and sub-surface depth profiles of impurities that can be obtained with this analytical procedure and gives by the way an average value for maximum depth of sub-surface cracks. Results are given with a relative precision of 10%.

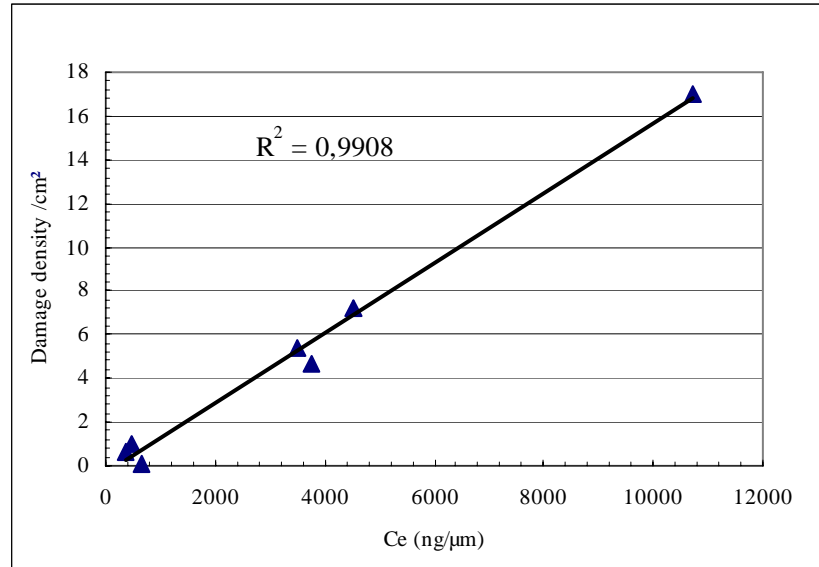
Fig. 4. Effect of cerium content on damage density.

machine before the manufacturing of our part. Insufficient cleaning of the polishing machine before the ZrO₂ polishing of samples B2 and B3 is therefore likely to be the cause of the cerium pollution of these parts. Moreover, it must be noticed that a high concentration of zirconium is compatible with low damage density such as seen on part B3. This last remark has already been made [16]. Figure 4 shows the correlation existing between cerium content in the interface and damage density at 14 J/cm².

Data are fitted with a linear law with a correlation coefficient of 0.99 approximately. At the opposite, Figure 5 presents the data for Fe where correlation between damage density and Fe concentration is very weak.

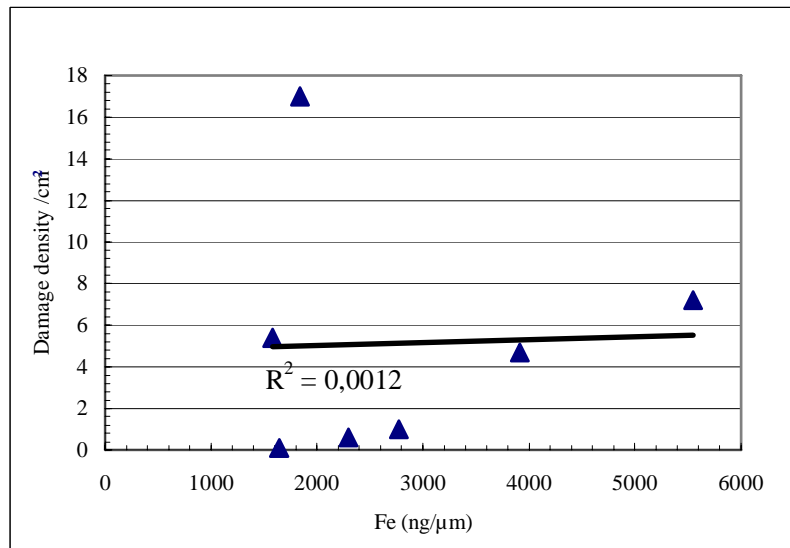
Fig. 5. Effect of Fe content on damage density.

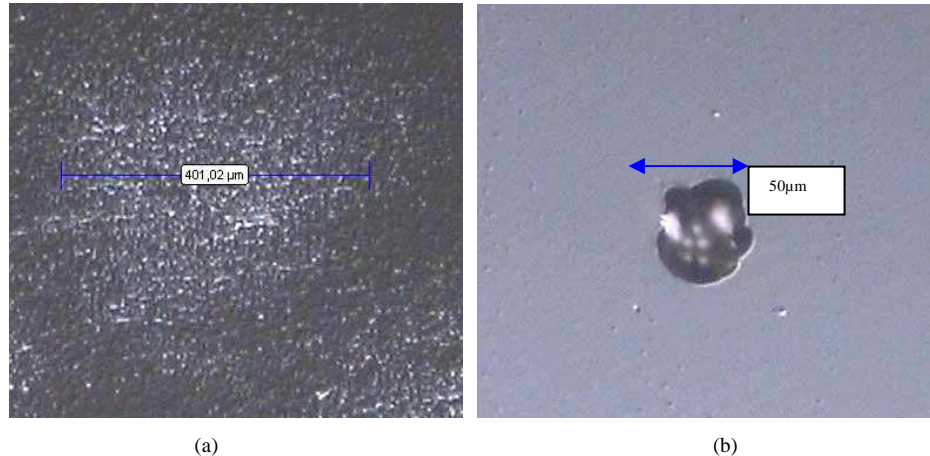
Fig. 6. (a) Gray haze damage, part B1 (b) typical damage morphology on part A4

We have also been trying to correlate the presence of cerium in the interface with damage morphology. On part B1 exhibiting very high cerium concentration in the interface, the "gray haze" damage morphology can be easily seen such as previously described by Kozłowski *et al.* [16]. Figure 6(a) shows such a gray haze damage like observed with a Nomarski microscope. When cerium content decreases, the gray haze morphology disappears to leave place to more classical small damage sites such as depicted in Figure 6(b). Some small damage clusters can be observed but no clear correlation has been seen between cerium concentration and quantities of these clusters like damage sites.
