**Impact of storage induced outgassing organic
contamination on laser induced damage of silica optics
at 351 nm**

Impact of storage induced outgassing organic contamination on laser induced damage of silica optics at 351 nm

Abstract: The impact of storage conditions on laser induced damage density at 351 nm on bare fused polished silica samples has been studied. Intentionally outgassing of polypropylene pieces on silica samples was done. We evidenced an important increase of laser induced damage density on contaminated samples demonstrating that storage could limit optics lifetime performances. Atomic Force Microscopy (AFM) and Gas Chromatography -Mass Spectrometry (GC-MS) have been used to identify the potential causes of this effect. It shows that a small quantity of organic contamination deposited on silica surface is responsible for this degradation. Various hypotheses are proposed to explain the damage mechanism. The more likely hypothesis is a coupling between surface defects of optics and organic contaminants.

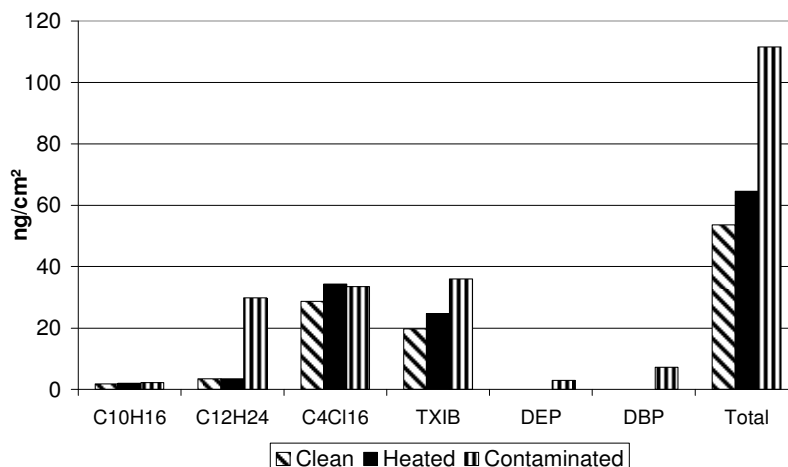
Fig. 5. Chemical species measured by GC-MS on clean, heated and contaminated silica samples

GC-MS analyses were performed to identify the nature of sample surface contaminants. Results are presented on Fig. 5.

The amount of each molecule measured is expressed in terms of mass per unit surface. Comparison of clean, heated and contaminated samples demonstrates that contamination carried out with NPP increased global amount of contaminant by a factor of 2. NPP contamination induces an additional contamination of diethylphthalate (DEP), dibutylphthalate (DBP) and $C_{12}H_{24}$. Additional GC-MS measures on contaminated samples confirmed this increase of a factor 2 compared with clean or heated sample. Other condensable molecules were found; which demonstrated that this mode of contamination generate a mixture of various condensable molecules on silica surfaces.

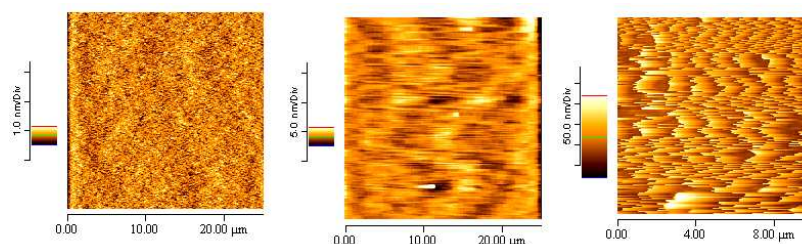
Fig. 6. AFM picture of bare silica samples after cleaning (a) and after contamination (b) – solvent spread on a fused silica sample (c)

AFM measurements were made to determine the morphology of the contaminant layer. The measurements after cleaning and after contamination with NPP were compared. The same areas were analyzed each time. After cleaning, as shown on Fig. 6a, all samples exhibit a root mean square roughness of 0.1 nm with a standard deviation of 0.01 nm; which is conform to manufacturer's roughness specifications. Then, we performed the same measures after contamination. As showed on Fig. 6b, on the contaminated sample, streaks appear on the picture. AFM manufacturers warn that these streaks are artifacts related to a tip contamination [19]. They appear especially in location where there are sharp features and edges on the sample surface such as scratches or digs.

These artifacts are relevant of a tip problem; the tip can be charged with liquid when scanned over the surface. To be sure that these artifacts are linked to the presence of liquid on the surface, a surface with a droplet of solvent deliberately deposited on it with a micro syringe, was measured. As shown on Fig. 6c, the presence of many streaks demonstrates that this behaviour of the tip is linked with the existence of a liquid film. Nevertheless, as this kind
