**Impact of storage induced outgassing organic
contamination on laser induced damage of silica optics
at 351 nm**

Impact of storage induced outgassing organic contamination on laser induced damage of silica optics at 351 nm

Abstract: The impact of storage conditions on laser induced damage density at 351 nm on bare fused polished silica samples has been studied. Intentionally outgassing of polypropylene pieces on silica samples was done. We evidenced an important increase of laser induced damage density on contaminated samples demonstrating that storage could limit optics lifetime performances. Atomic Force Microscopy (AFM) and Gas Chromatography -Mass Spectrometry (GC-MS) have been used to identify the potential causes of this effect. It shows that a small quantity of organic contamination deposited on silica surface is responsible for this degradation. Various hypotheses are proposed to explain the damage mechanism. The more likely hypothesis is a coupling between surface defects of optics and organic contaminants.

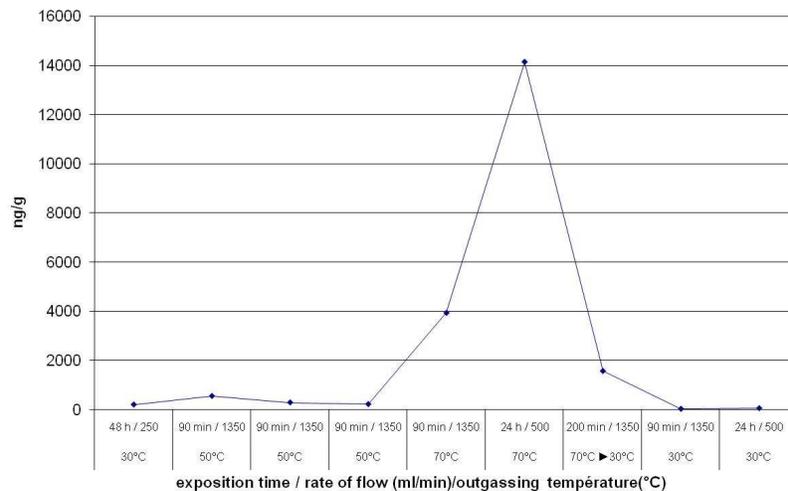
Fig. 1. Outgassing rate of polypropylene at different temperatures, flow rates and durations

The amount of outgassing species increases with the duration and the temperature. Maximal outgassed quantity is measured around 70°C. The outgassing rates of major

molecules measured at 70°C during 24 h and at 30°C during 48 h corresponding to the first and sixth points of Fig. 1 are given in Fig. 2.

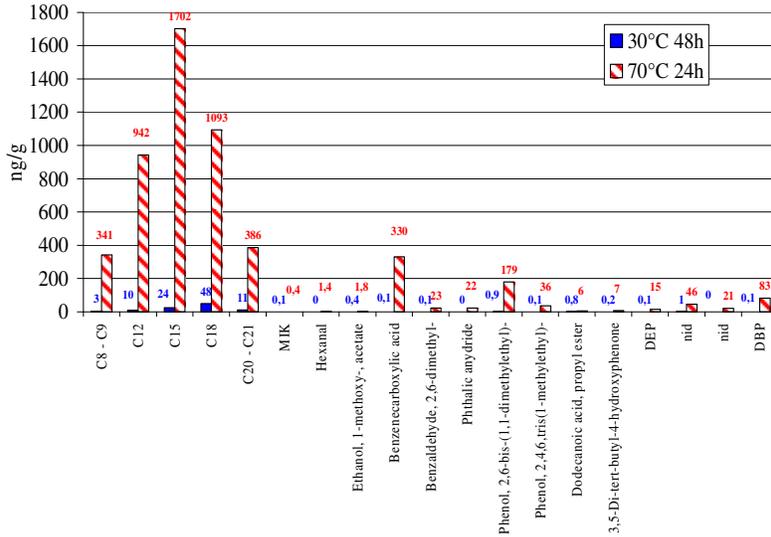
Fig. 2. Outgassed species at 70°C during 24 h by the selected polypropylene

The detected compounds were measured during the whole duration of the outgassing cycle. The alkanes and alkenes come probably from decomposition of other higher molecules. Dibutylphthalate and diethylphthalate are esters of phthalic acid and are mainly used as plasticizers, substances added to plastics to increase their flexibility. The other molecules are measured at the beginning as well as at the end of the outgassing cycle; consequently, they probably come from NPP material and not from a surface contamination of the analyzed NPP sample. Moreover, outgassed species at 70°C and at 30°C are similar. It means that an outgassing at 70°C during 24 h can be equivalent to an outgassing at 30°C during many days which is representative of a long term outgassing such as optics storage conditions. Consequently a temperature of 70°C during 24 h was chosen for the outgassing contamination phase.

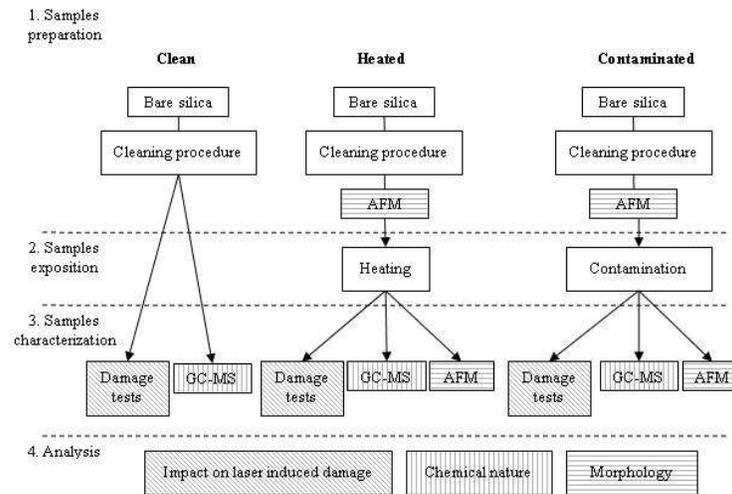
Fig. 3. Experimental protocol

We used plano-parallel Corning 7980 fused silica polished samples. An experimental protocol detailed in Fig. 3, was used for contamination, for laser damage tests and for characterization. Preliminary, samples were cleaned using an automated cleaning procedure in a spray system machine with RBS 50 soap followed by an ethanol drag wipe. At this step, all bare samples exhibit the same laser induced damage density as typical clean LMJ optics, that is to say approximately 0.1 damage/cm² at 351 nm, for 10 J/cm², and 3 ns pulse length. The contamination process is then carried out in the following way: the sample to be contaminated is placed in a clean glass box with 60 g of NPP. Silica sample and NPP in the glass box are then put in an oven programmed to do a cycle consisting in a rising slope of 6 h to 70°C followed by a stage of 24 h at this temperature and an abrupt return at ambient temperature during 15 min to help condensation of the outgassed species on the silica surface. To avoid any external contamination and guaranty the repeatability of the contamination process, glass box and NPP sample are cleaned in a washing machine with L51 soap followed by an ethanol cleaning prior to contamination experiment. To evaluate the impact of NPP outgassing, each contaminated sample is compared with a reference clean sample. Nevertheless, as the contaminated phase includes a heating cycle, a second reference sample is used; it is cleaned with the previous procedure and is heated with the previous temperature cycle without NPP in a similar glass box. These references were used for the following samples characterization

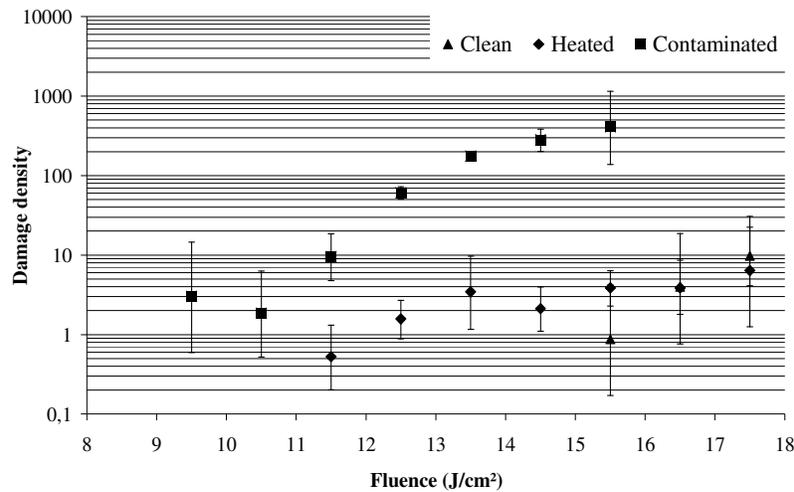
Fig. 4. Laser induced damage tests of clean, heated and contaminated silica samples

Laser induced damage tests have been made on several clean, heated, and contaminated silica samples. The total surface tested is about 100 cm² for each type of sample. Results are presented on Fig. 4. Firstly, damage tests reveal that clean and heated samples are similar. It demonstrates that the outgassing protocol without NPP has no effect on damage density. Laser damage tests on clean sample did not generate damage at fluences below 14 J/cm². Secondly, the impact of NPP outgassing is significant. Indeed, from 11 J/cm² to 14 J/cm², damage density is increased by a factor of 5 to 200 on contaminated samples.

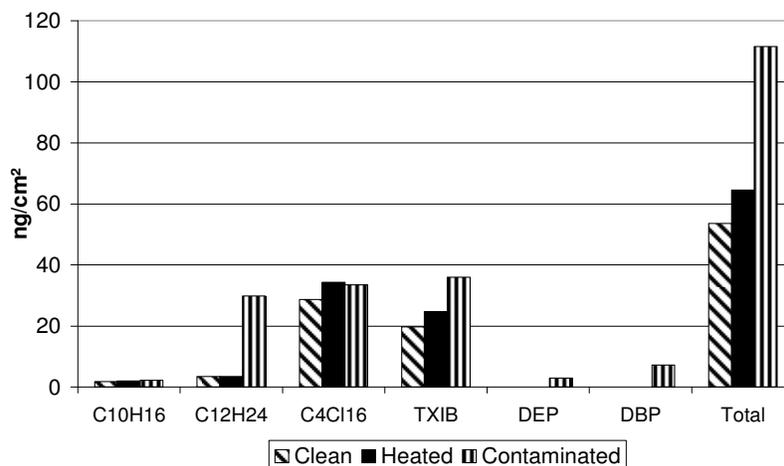
Fig. 5. Chemical species measured by GC-MS on clean, heated and contaminated silica samples

GC-MS analyses were performed to identify the nature of sample surface contaminants. Results are presented on Fig. 5.

The amount of each molecule measured is expressed in terms of mass per unit surface. Comparison of clean, heated and contaminated samples demonstrates that contamination carried out with NPP increased global amount of contaminant by a factor of 2. NPP contamination induces an additional contamination of diethylphthalate (DEP), dibutylphthalate (DBP) and $C_{12}H_{24}$. Additional GC-MS measures on contaminated samples confirmed this increase of a factor 2 compared with clean or heated sample. Other condensable molecules were found; which demonstrated that this mode of contamination generate a mixture of various condensable molecules on silica surfaces.

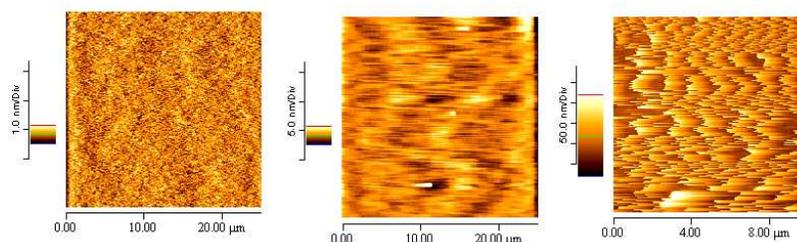
Fig. 6. AFM picture of bare silica samples after cleaning (a) and after contamination (b) – solvent spread on a fused silica sample (c)

AFM measurements were made to determine the morphology of the contaminant layer. The measurements after cleaning and after contamination with NPP were compared. The same areas were analyzed each time. After cleaning, as shown on Fig. 6a, all samples exhibit a root mean square roughness of 0.1 nm with a standard deviation of 0.01 nm; which is conform to manufacturer's roughness specifications. Then, we performed the same measures after contamination. As showed on Fig. 6b, on the contaminated sample, streaks appear on the picture. AFM manufacturers warn that these streaks are artifacts related to a tip contamination [19]. They appear especially in location where there are sharp features and edges on the sample surface such as scratches or digs.

These artifacts are relevant of a tip problem; the tip can be charged with liquid when scanned over the surface. To be sure that these artifacts are linked to the presence of liquid on the surface, a surface with a droplet of solvent deliberately deposited on it with a micro syringe, was measured. As shown on Fig. 6c, the presence of many streaks demonstrates that this behaviour of the tip is linked with the existence of a liquid film. Nevertheless, as this kind

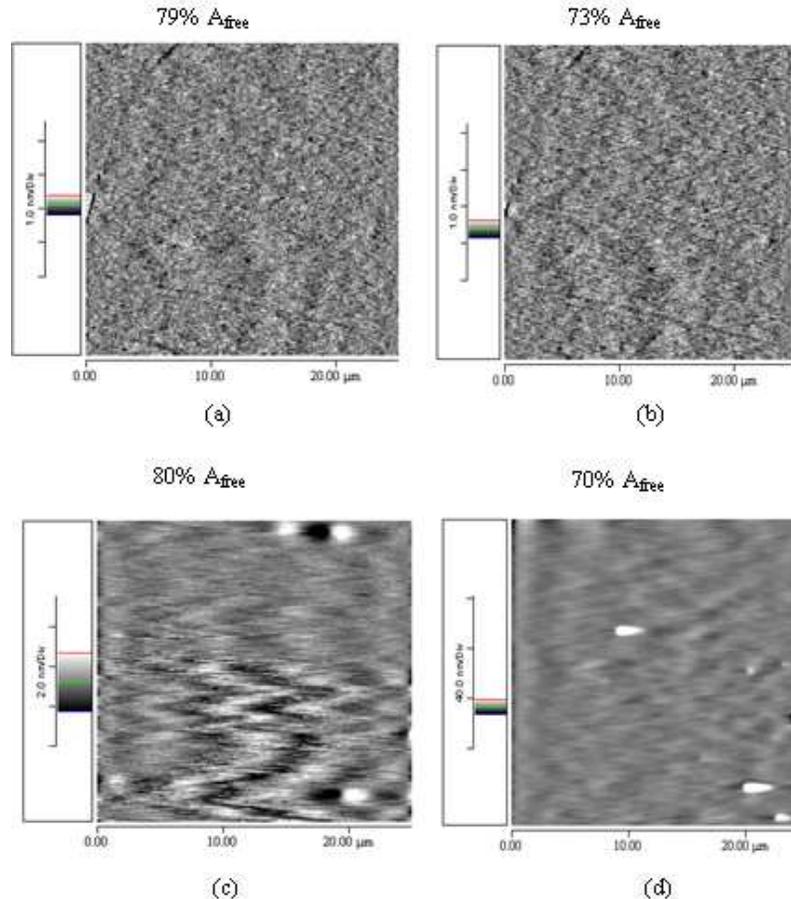
Fig. 7. AFM picture of bare silica samples after cleaning (a and b) and after contamination (c and d) for different set point amplitude values

of pictures can also be attributed to the fact that the approach of the tip is not effective, complementary experiments were performed. AFM images of clean silica samples and contaminated ones were made with different set point amplitude values (Fig. 7). For 79% or 73% of the free amplitude, respectively images a and b of Fig. 7, clean bare silica surface is well distinguishable. We found the same root mean square roughness certified by the manufacturer. On contaminated samples, for low forces (80% of the free amplitude, Fig. 7c) the tip generates streaks and for higher force (70% of the free amplitude, Fig. 7d), the silica surface is still not apparent. Indeed, at the end of the measure, after the withdrawal step, the natural oscillating amplitude of the tip has decreased of about 20 nm and a shift of natural frequency was noticed. In normal conditions, the natural oscillating amplitude and frequency come back to the ordered values at the end of the withdrawal.

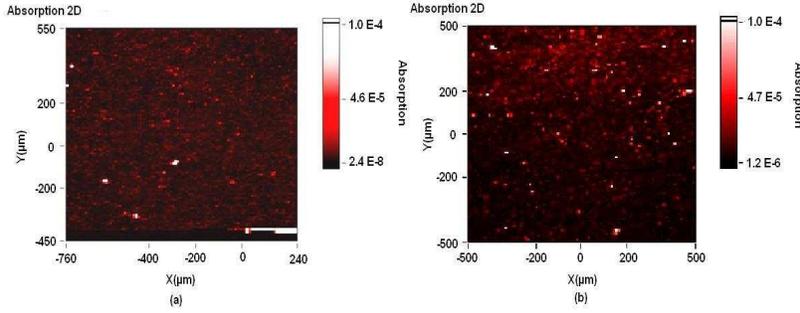
Fig. 8. Absorption mapping of clean (a) and contaminated (b) samples obtained by photothermal deflection with a sampling step of 20 μm

The measurements were made on various areas of the sample and two times for each kind of sample. The same result has been found each time, which indicate that the signal is independent of the liquid contamination morphology. An example of experimental measurement results is given in Fig. 8

For the clean sample, a mean value of $2.93 \cdot 10^{-5}$ with a standard deviation of $4.08 \cdot 10^{-6}$ was measured; for the contaminated sample, a mean value of $1.95 \cdot 10^{-5}$ with a standard deviation of $9.43 \cdot 10^{-6}$ was measured. The difference between the clean and the contaminated sample is not significant showing that contamination does not affect absorption mappings. This technique is not adapted to measure such absorption. Furthermore, the more absorbing points visible are due to micrometer sized particles on the sample. We must outline that Palmier demonstrated that particles cannot be linked to damage in similar conditions (polished fused silica samples damage tested at 351 nm) [22,23].
