## Luminescence study of defects in silica glasses under near-UV excitation

Jérôme Neauport, Jessica Fournier, P. Grua, Evelyne Fargin, Veronique Jubera, et al.. Luminescence study of defects in silica glasses under near-UV excitation. *Physics Procedia*, 2010, 8, pp.39-43. 10.1016/j.phpro.2010.10.009 . cea-01692824

## Luminescence study of defects in silica glasses under near-UV excitation.

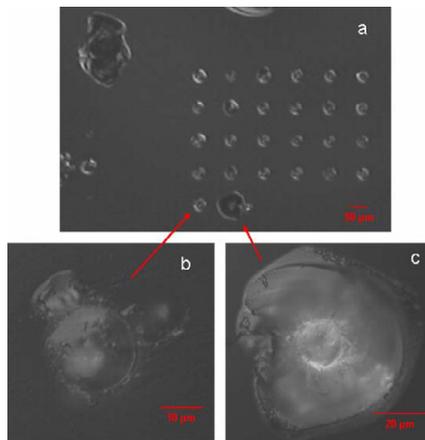
Despite the fact that our experimental parameters are constant, resulting indentation sites are not equivalent from site to site as shown on Figure 1. We chose indentations shown on Figures 1b and 1c for our luminescence study. They are referred to as indentation 1 and indentation 2.

Figure 1. (a) Image of indentations matrix, (b) and (c) enlargement of the two analysed indentations.

The luminescence spectra (Figure 3a), obtained for the indentation 1 (Figure 1b) and the indentation 2 (Figure 1c), show different characteristics. The spectrum is shifted to lower energies when the indentation induces more fractures. In order to identify the defects, the spectra (Figure 3b) are decomposed using Gaussian curves. The parameters of the fit are given in Table 2.

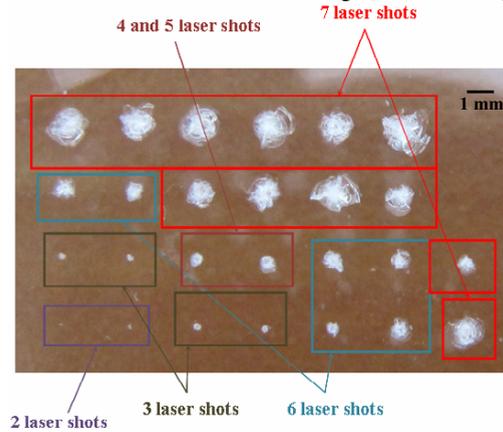
We create laser damage in our samples with a Nd:YAG laser, at 351 nm wavelength, 2.7 ns pulse duration, and a 6mm beam diameter. The laser fluence is about 40 J/cm<sup>2</sup>. For each damage site, we use a multi-shot technique (one to seven shots per site) in order to obtain different sizes of damages, as seen on Figure 2.

Figure 2. Image of laser damage matrix.

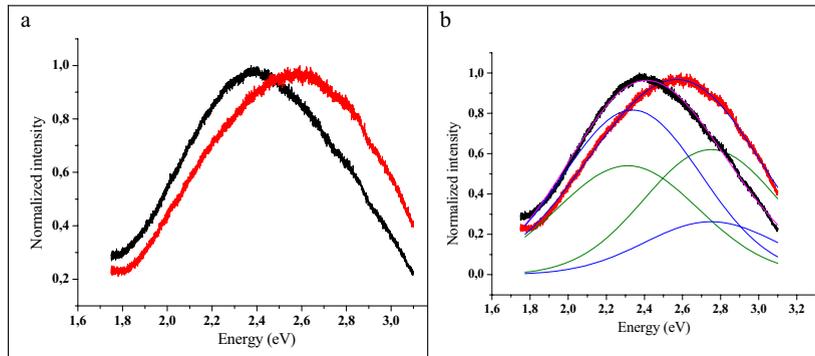
Figure 3. a) Comparison of photo luminescence spectra excited at 325 nm for indentations: indentation 1 (red) and indentation 2 (black); b) Comparison of fitted spectra for the two indentations: indentation 1 (green) and indentation 2 (blue).

The parameters used are in good agreement with those found in literature [2-3]. The spectra fits show that two defects are present in the indentations. The first one around the 2.3 eV band is not attributed to a known defect. The second band at 2.75 eV is attributed to the Oxygen Deficient Center [1].

We show that indentations and laser damage craters give rise to different spectra. In indentations, only two defects are present: ODC and an unknown defect emitting around 2.2 eV. The luminescence bands are also larger than for laser damage. In laser damage, there are three luminescence bands which are ODC, NBOHC and the unknown defect emitting at 2.2 eV. Concerning this defect, two hypotheses are mainly proposed. The first one concerns the Self Trapped Exciton [2,6]. This defect is strongly luminescent under 150 K but at room temperature it may still have a weak luminescence. The second hypothesis involves an  $E'_{\delta}$  center located in small silicon clusters [3-5], since a correlation between the Electron Paramagnetic Resonance signal of  $E'_{\delta}$  center and the luminescence band around 2.2-2.3 eV was evidenced from the study of  $\gamma$ -irradiated amorphous silicon.

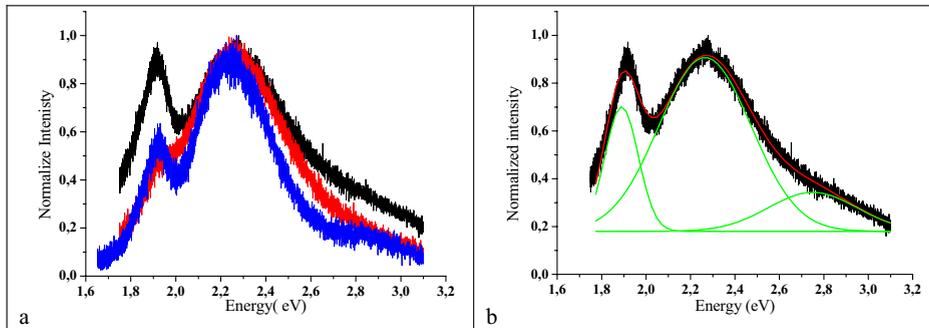
First results obtained on laser damage seem to indicate that the luminescence behaviour of defects is strongly correlated to the nature of damages (figure 4a). Strong differences are observed in the relative intensity of the emission bands. In all the cases, the emission bands can be fitted by three Gaussian curves (Figure 4b: only the Gaussian fit for the two laser shots is shown), parameters are given in Table 3. The corresponding curves are in good agreement with parameters found in literature [2-3]. Three luminescence bands are present in laser damages in different ratios. The first band at 1.89 eV corresponds to the NBOHC defect [1-5]. The second band at 2.25 eV is, to our knowledge, not related to a known defect. Finally, the third defect at 2.75 eV corresponds to ODC defect [1,2,4,5].

Figure 4. a) Comparison of luminescence spectra for 2 laser shots (black), 4 laser shots (red), and 5 laser shots (blue); b) Fitted luminescence spectra for two laser shots (black: experimental data, green: partial fits, red: final fit).
