TEM Examination of a Swelling-Resistant Austenitic Steel Irradiated at High Temperature (>600°C) in the Phénix Fast Reactor.

A.Courcelle¹, M. Jublot¹, E. Piozin¹, P. Gavaille¹, C. Bisor², J.L. Séran²

Abstract. In the framework of the Sodium Fast-Reactor (SFR) project ASTRID, an optimized austenitic steel 15%Cr-15%Ni, stabilized with Ti, was chosen for the fuel-pin cladding. Besides irradiation swelling, one of the main issue of irradiation is the embrittlement at high temperature (>600°C). To investigate the long-term behavior of this alloy irradiated at temperatures greater than 600°C, fuel pins clad with optimized Si-enriched 15-15Ti, were irradiated in several experimental assemblies of the Phénix reactor to reach a cumulative irradiation time of 941 days (EFPD Equivalent Full Power Day). Thin foils suitable for Transmission Electron Microscope (TEM) were taken from the upper part of the fuel pin where the irradiation temperature is maximum and exceeds 600°C. The final dose of the irradiated thin foil is about 40 dpa NRT. TEM observations were carried out to characterize irradiation defects, dislocation network and precipitations in order to identify the possible embrittlement

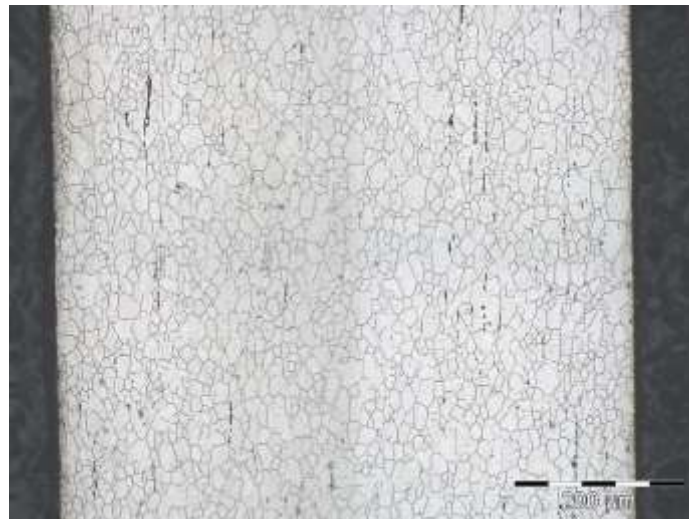
FIG. 1. Metallography of the cladding showing austenitic grains and primary carbide precipitates.

After the last solution-annealed treatment, the final geometry of the tube (outer diameter 6.55mm and thickness 0.45mm) was achieved by cold drawing (cold-working level of 23%). No thermal treatment was performed after the cold deformation step. The chemical composition directly measured in the tube is given in TABLE 1. The composition leads to a fully austenitic structure (grain size 20 μm) without ferrite. Only primary TiMo(C,N) nitro-carbides are present in the microstructure. Alignment of primary precipitates in the drawing direction are visible in the metallography displayed in FIG. 1.

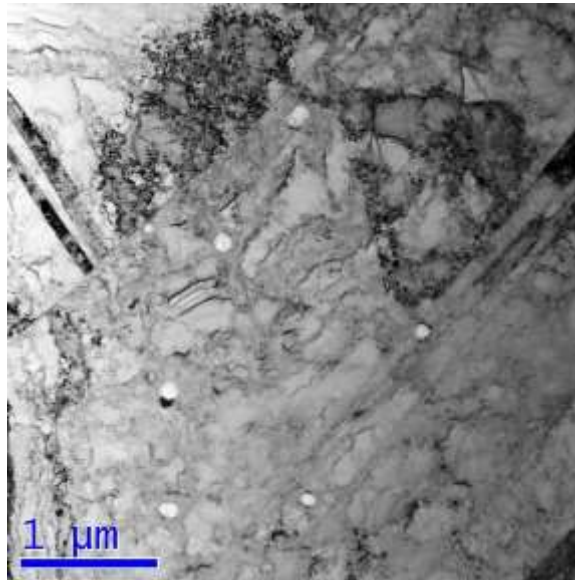
FIG. 2. Bright-field TEM image showing the general microstructure before irradiation with high dislocation density, twins and few dislocation cells as well as primary Ti-Rich MC precipitates.

TEM examination before irradiation shows a high dislocation density and mechanical twins due to the 20% cold working (See FIG. 2.). Induced by the cold deformation, local rearrangements of dislocations into cells are observed. Only primary TiMo(C,N) precipitates are present and no nanoprecipitates of rich-Cr carbides were detected.

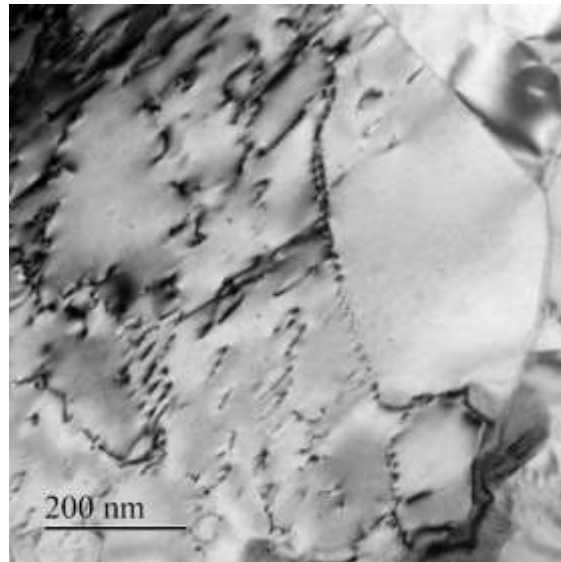
FIG. 3. TEM bright field image of dislocations microstructure showing rearrangement due to recovery mechanisms.

Dislocation network A possible high-temperature issue of cold-worked Ti-stabilized steels is the risk of extensive recovery and possibly radiation-induced recrystallization during service life. Studies suggest that 15-15Ti alloys with high Si can recrystallize at a lower temperature than under thermal aging [1]. In the present examination, extensive primary recrystallization did not occur. However recovery mechanisms are clearly visible and caused a decrease of dislocation density. Rearrangement of dislocations and creation of free dislocation cells with a uniform TEM contrast is shown in FIG. 3. This dislocation-free zones are often formed at triple-junction points and could act as recrystallization nuclei.

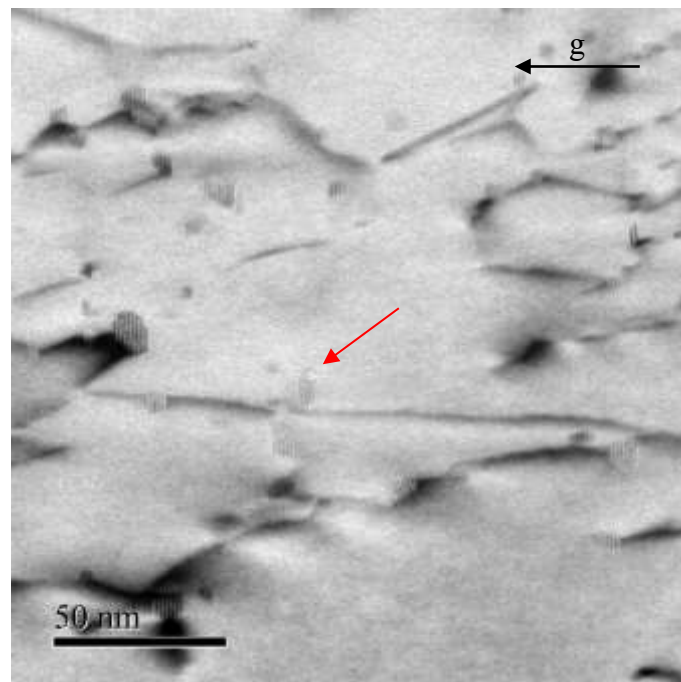
FIG. 4. TEM image of nanoprecipitates MC (Moiré fringes) in bright field condition with diffracting vector $\mathbf{g}=\langle 002 \rangle$. Red arrow shows a small bubble nucleated at the TiC-matrix interface.

Nanoprecipitation Ti-stabilized alloys were designed to create a fine dispersive precipitation of Ti-rich MC precipitates when exposed to a high temperature thermal treatment. As shown in FIG. 4, MC were identified in bright field condition using the Moiré fringes (caused by the slight difference in the Fm3m lattice parameter between the precipitates and matrix) with a diffraction vector $\mathbf{g}=\langle 002 \rangle$. In this condition, the measured average spacing of the Moiré fringes gives a MC lattice parameter of $a_0 = 0.42$ nm (assuming matrix lattice parameter $a_0 = 0.36$ nm measured in the unirradiated sample). As in thermal treatments, the nucleation of MC is clearly enhanced in dislocations. The MC nanoprecipitation is homogeneously distributed in the sample.

Bubbles and vacancy clusters: small bubbles are visible inside matrix grains and in grain boundaries (see FIG. 6.). Some bubbles also nucleate heterogeneously at nanoprecipitate surfaces (FIG. 4) and at interfaces between matrix and larger precipitates (FIG. 7). The presence of large cavities (vacancy clusters) is not expected at 600°C because of the high probability of thermal dissociation. The stable bubbles observed in the present work are more likely helium bubbles. The helium generation rate in the upper part of the cladding is between 0.2 and 0.5 appm/dpa (due to n,α reactions). In the literature [3], the formation of helium bubbles at grain boundaries is believed to contribute to the embrittlement of irradiated austenitic steels at high temperature (reduction of ductility in tensile test, reduction of rupture time in creep test). Note that very few studies with neutron-irradiated samples directly show the presence of helium bubbles. Most of the data come from helium-implanted samples or indirect correlations between creep properties and helium content.

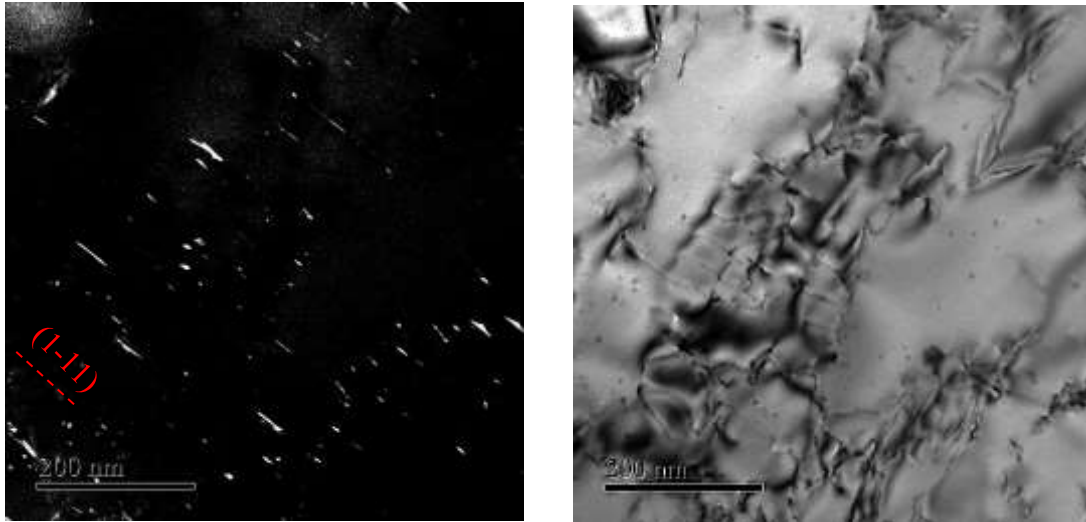
FIG. 5. Dark field TEM image with the rel-rod technique of Frank loops (1-1 1) in two-beam condition $B=[110]$ $g=<-113>$ (left Figure) and the corresponding bright field image (right Figure)

Frank loops Faulted Frank loops were identified in dark field images by the rel-rod technique (see FIG. 5). The largest loops reach 60 nm in size. Larger faulted loops are not present because they are unstable and tend to unfault. Frank loops are homogeneously present in the sample, except inside free dislocation cells indicating that recovery process eliminates Frank loops.

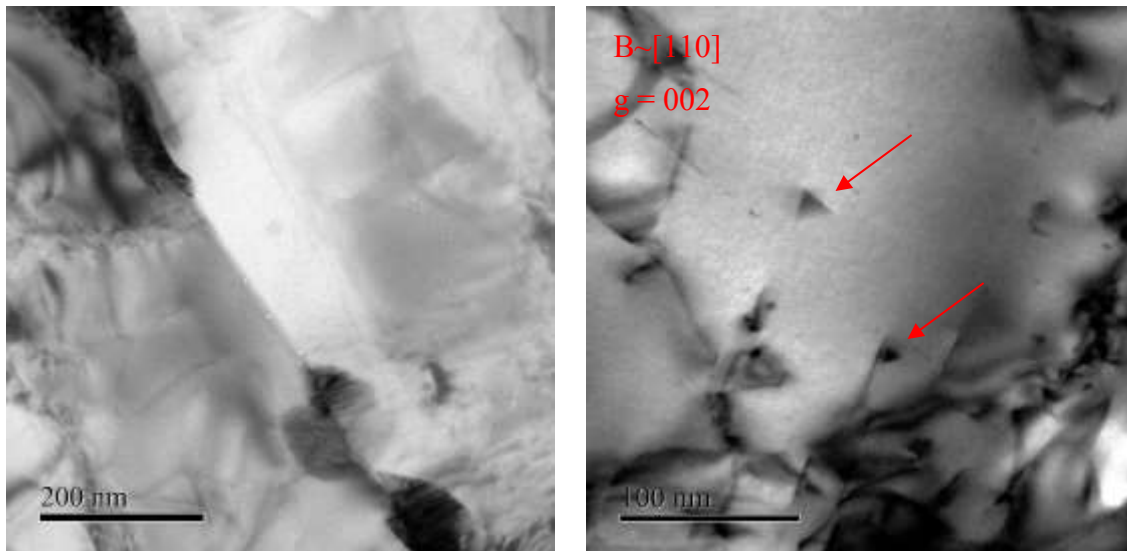
FIG. 6. TEM bright field image showing intergranular bubbles between precipitates (left figure) and triangular-shaped defects, (right figure) indicated by the red arrows.

Triangular-shaped defects with a rather low density are also observed with sample oriented in two beam condition $B=[110]$ $g=<002>$ as shown in FIG. 6. Triangular-shaped contrasts in TEM image can be the result of overlapping defects in the electron beam direction. Stacking Fault Tetrahedra (SFT) have also a similar contrast but were rarely observed in commercial steels irradiated at 600°C [2]. Further examinations are needed to determine the nature of these defects.

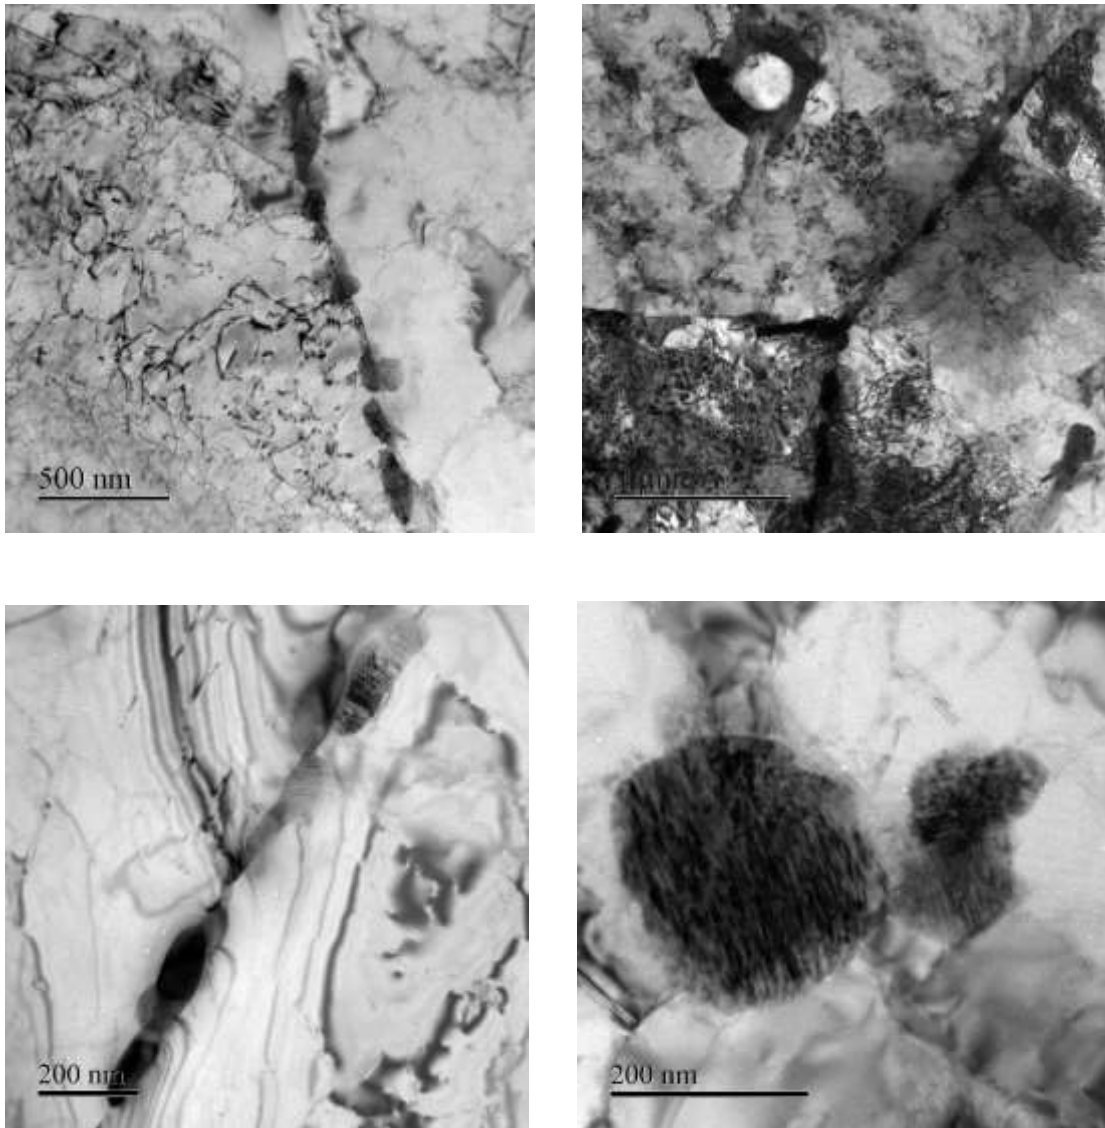
FIG. 7. Overview of coarse intra and intergranular precipitates. Note that precipitate surfaces promote bubble nucleation.

Intergranular precipitation: One of the striking feature of the irradiated microstructure is the abundant presence of intergranular precipitates as displayed in FIG. 7. Coarse precipitates are also formed around primary MC, inside matrix grains. Several types of precipitates coexist as indicated by EDS (Energy Dispersive X-ray Spectroscopy) analysis in FIG. 8. Compared to the matrix, one type of precipitates is enriched in Ni, Ti and Si which is consistent with the G phase composition [4]. Another family of precipitates is enriched in Mo and Si (Si/Mo \sim 0.5). This type of precipitate contains a high density of stacking faults as observed on the bottom-right image of the FIG. 7. Above 600°C, the literature for Ti-stabilized austenitic steel reports the formation of laves phases (Hexagonal structure with space group $P6_3/mmc$) with high Mo contents and appearing as faulted laths. M₆C (space group $Fd\bar{3}m$ diamond cubic) and G phases (fcc structure with space group $Fm\bar{3}m$) are also commonly observed. Selected Area Diffraction (SAD) studies are in progress to identify the crystallographic structure of the precipitates and to confirm their nature.

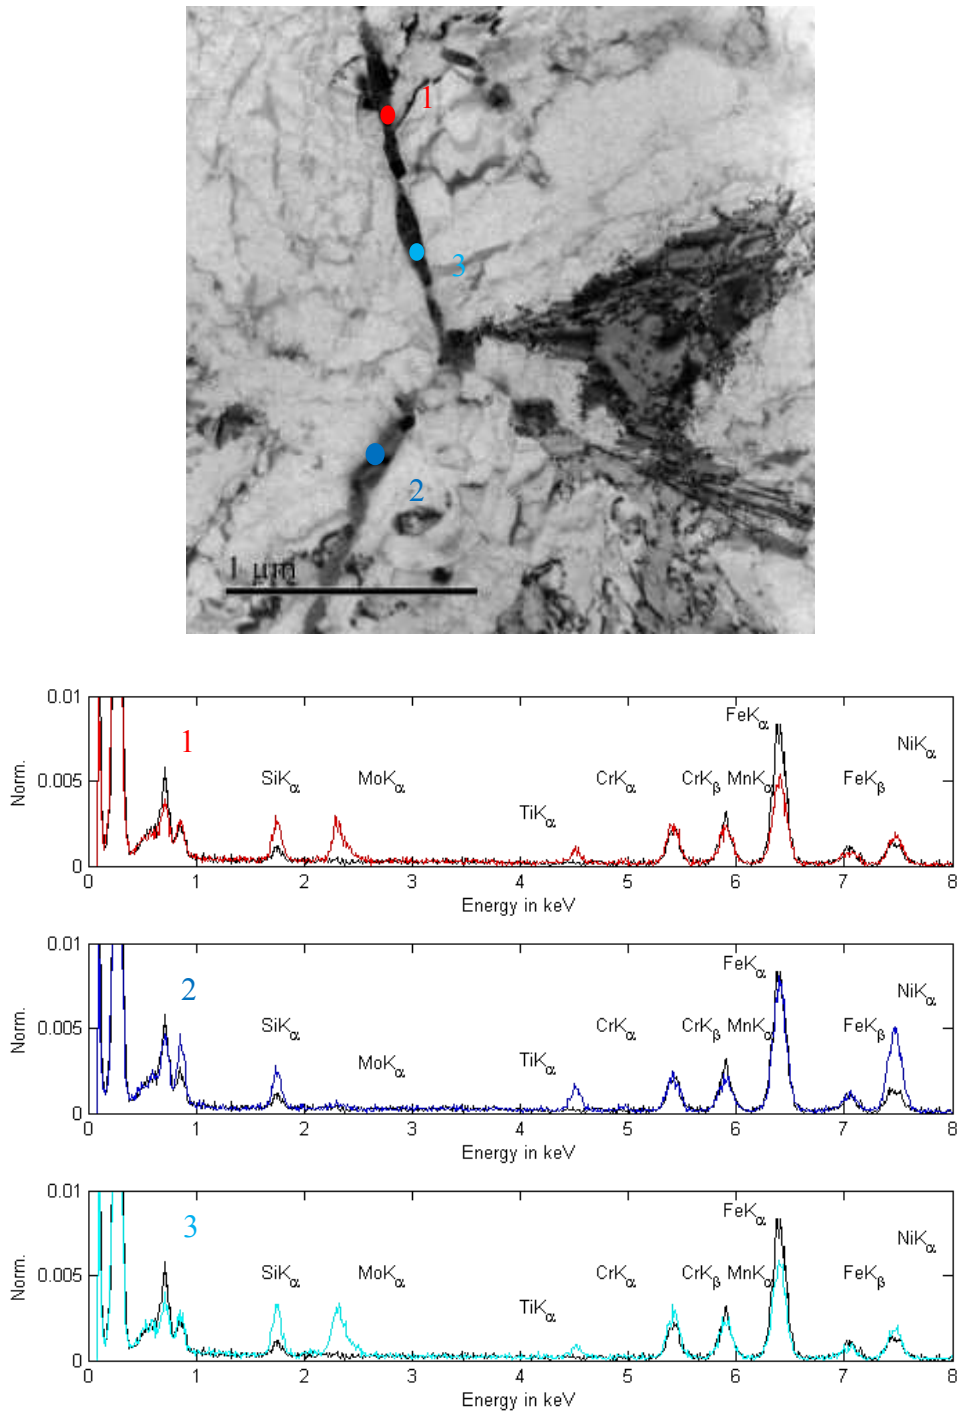
FIG. 8. EDS Spectrum of matrix (black curves) compared with several EDS spectra of precipitates (color curves). Spectra are not corrected for Mn radioactivity.
