Refurbishment of a Nuclear Facility in operation : Focus on the check and thorough maintenance of hot cell's handling equipment

P. Gruber, L. Bruguiere, J.-M. Idasiak

¹French Alternative Energies and Atomic Energy Commission, Nuclear Energy Division,
CEA Marcoule – Installation de Surveillance des Assemblages Irradiés, Bagnols sur Cèze, France

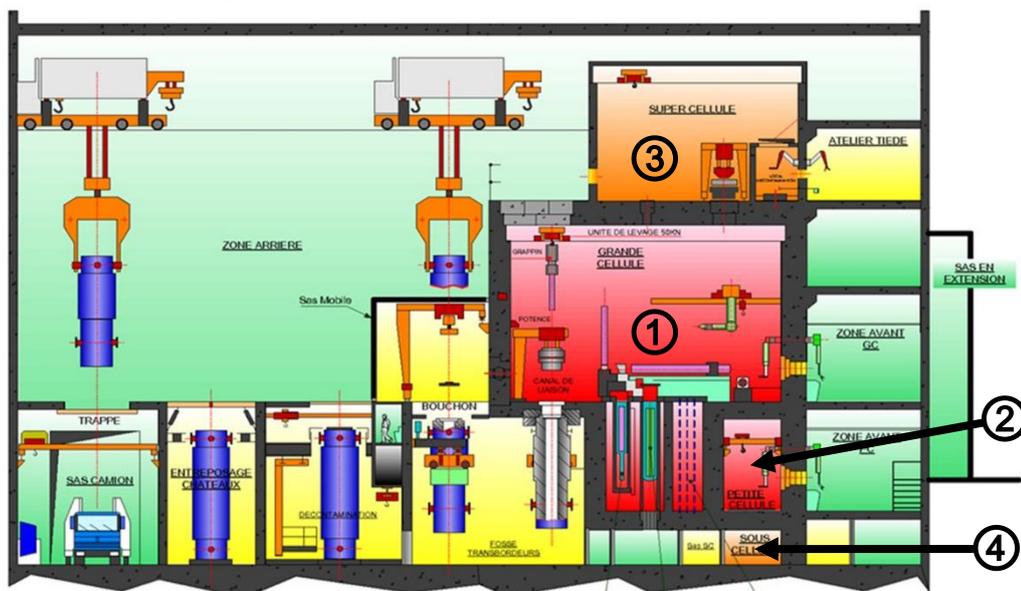
Figure 1. ISAI plan and operation cinematic.

The operation cinematic is organized around the cell's block formed by two hot cells in red zones (totally forbidden for humans) called "Large Cell" (① figure 1) and "Small Cell" (② figure 1) and their intervention cells called "Super Cell" (③ figure 1) and "Under Cell" (④ figure 1) respectively.

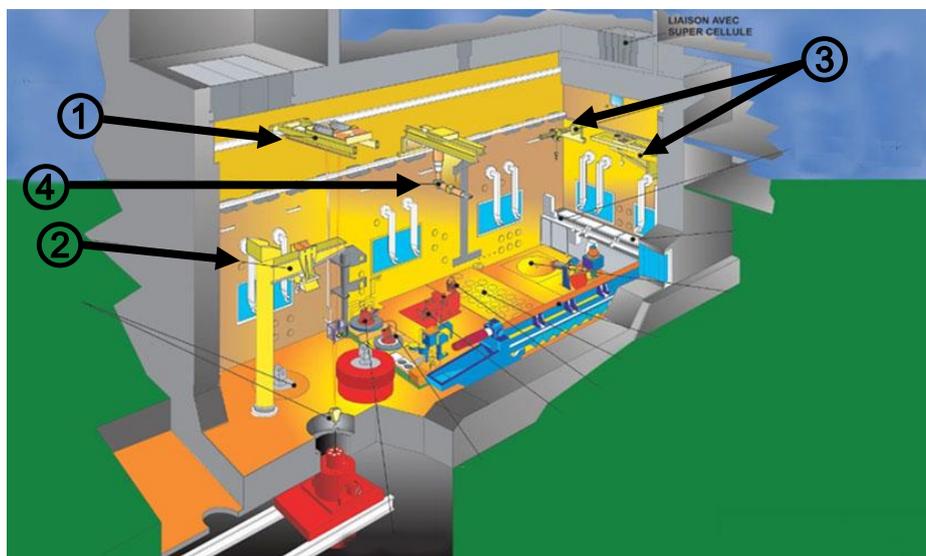
Figure 2. Large Cell Plan

- _A 5-ton double girder overhead travelling crane (① figure 2),
- _A 10-ton pillar jib-crane (② figure 2),
- _Two single girder wall travelling crane 250 kg and 500kg capacity each (③ figure 2),
- _A power telemanipulator 250 kg capacity (④ figure 2) on a 2-ton double girder overhead travelling crane.

They were installed between 1983 and 1984 and most of their components are removable and portable in the “super cell” for maintenance or reparation. The Large Cell is a red zone and strictly forbidden to humans’ intervention because of radiological conditions.

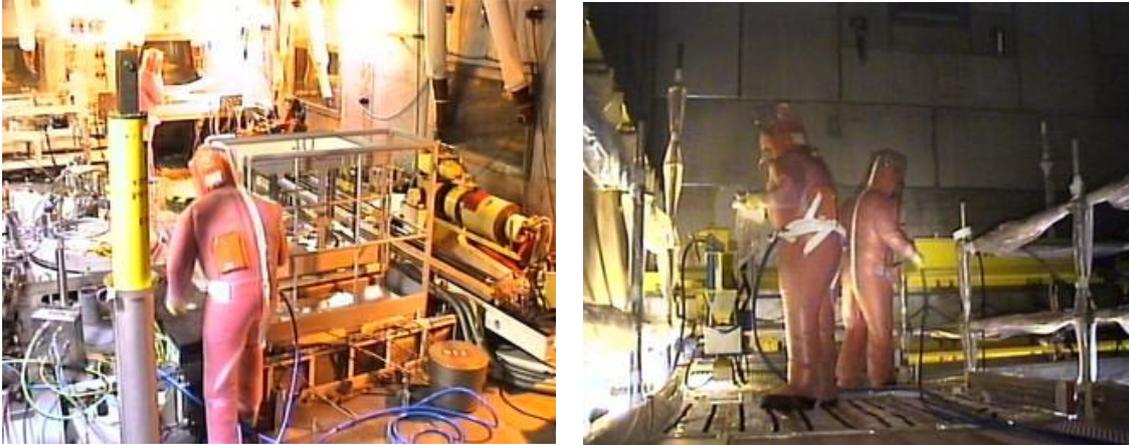
Figure 3. Cleaning-up floor and + 5m

First, a cartography of contamination was made with telemanipulator to determine humans intervention conditions after evacuation of all irradiative source term of the cell. The aim was to attain low contamination to authorize maintenance intervention without Air Fed suits.

The height of handling equipment needed introduction and progressive assembling scaffolding on the entire square of the cell at successive different height (3m, 5m and 7m). For each level, clean-up was necessary.

A complete contamination and irradiation cartography per square meters from floor to ceiling permitted to decommission temporary from red zone to orange one.

The global radiation dosimetry of this operation was approximately 3,4 mSv for 108 interventions of 2 hours each.

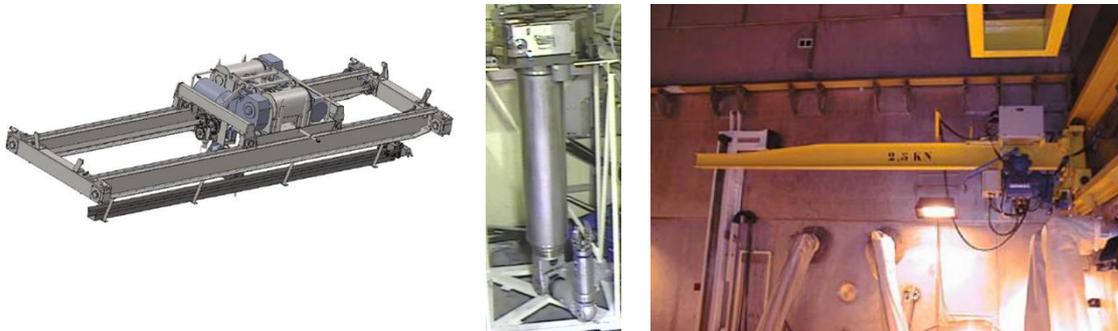
Figure 4. Overhead crane (3D model) - Power telemanipulator - Single girder wall travelling crane

The preparation of this operation consisted in considering each crane to identify unattainable parts and potentially worn parts. All long-lead items were ordered at the earliest.

All final as-built drawings of 1983 were used to fabricate the elements and to model the equipment in three dimensions.

The operators also checked the clamping strength of the handling equipment's anchor in the cell.

The expertises on the different equipment showed the thorough maintenance of unattainable part should permit to limit future operating incident and perturbation on the ISAI evacuation capability.
