WEST regular in-vessel inspections with the Articulated Inspection Arm robot

V. Bruno^{*}, L. Allegretti^a, A. Barbuti^a, S. Bremond^a, Y. Cheng^b, C. Dechelle^a, N. Dufour^a, H. Feng^b, L. Gargiulo^a, D. Mouyon^a, B. Santraine^a, S. Shi^b, Y. Song^b, Y. Sun^b, E. Villedieu^a, B. Vincent^a, L. Zheng^b

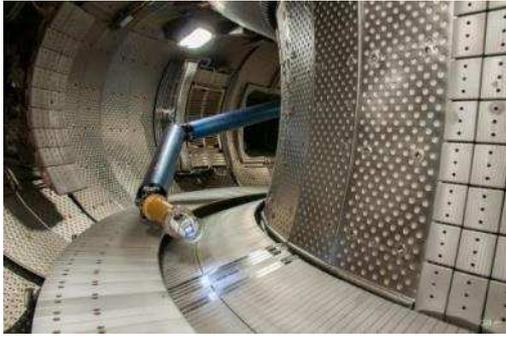
Fig. 12 - AIA with the low resolution camera observing the W PFUs

Since December 2017, 15 deployments (13 under vacuum) have been achieved in WEST for monitoring inner components (Fig. 13, Fig. 14, Fig. 15, Fig. 16), enabling to assess status of PFCs without opening the vessel (Fig. 12). The robot was also used for diagnostics assembly, assisting the introduction of the wide angle IR camera under nitrogen atmosphere or checking reciprocating Langmuir probes proper operation.
