Laser induced damage of fused silica polished optics due to a droplet forming organic contaminant

We report on the effect of organic molecular contamination on single shot laser induced damage density at the wavelength of 351 nm, with a 3 ns pulse length. Specific contamination experiments were made with dioctylphthalate (DOP) in liquid or gaseous phase, on the surface of fused silica polished samples, bare or solgel coated. Systematic laser induced damage was observed only in the case of liquid phase contamination. Different chemical and morphological characterization methods were used to identify and understand the damage process. We demonstrate that the contaminant morphology, rather than its physicochemical nature, can be responsible for the decrease of laser induced damage threshold of optics. © 2009 Optical Society of America

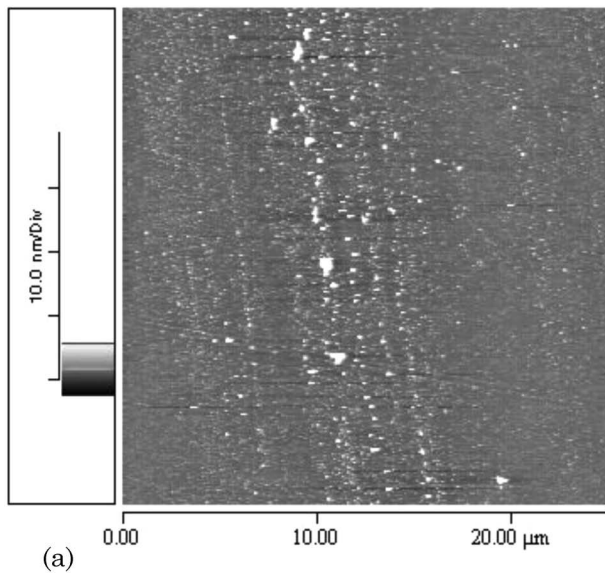
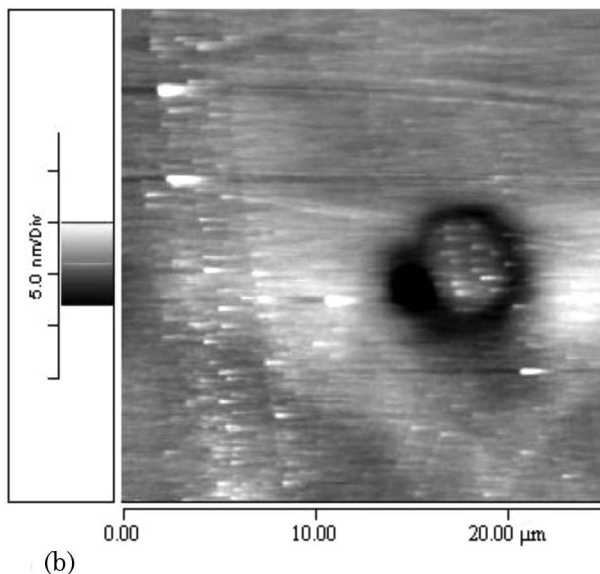
Fig. 2. AFM observation of a sample (a) before and (b) after DOP contamination in gaseous phase.

the quantity of DOP on the contaminated sample is more than 3 times higher than on the reference sample. The presence of DOP on the reference is not surprising as it is a usual contaminant of surfaces. 1300 ng of DOP found on the contaminated sample corresponds to a thickness of about 3 nm. For the morphology study of the deposit, atomic force microscopy (AFM) is used. Imaging was performed with a thermomicroscope autoprobe CR Research AFM. Silicon cantilevers with a force constant of about 40 N/m were used with a silicon tip (NCL Nanosensor). All operations were carried out in air at room temperature inside a glove box under relative humidity of 20–25%. Images were collected by the tapping mode and are presented in Fig. 2. Figure 2 compares the same area before and after contamination. Substantial contamination at the surface of a sample such as an oil film can cause AFM image artifacts [15]. Such artifacts appear as streaks on the images, especially in locations where there are sharp features and edges on the sample surface such as scratches or digs. It is exactly what we see in Fig. 2. Each of the specks in Fig. 2(a) correspond to streaks on the images after contamination in Fig. 2(b). Therefore the AFM observations show, on the surface of the optics, the presence of a film that is known to be mainly DOP as confirmed by GC-MS experiments as detailed previously. In summary, AFM and GC-MS experiments demonstrate the presence of a nanometric film of DOP adsorbed on the samples during gaseous contamination.

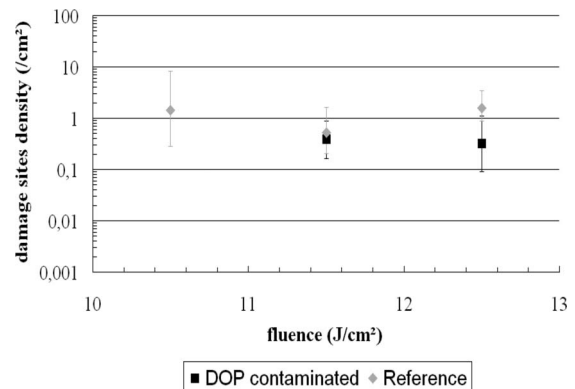
Fig. 3. Comparison of laser damage density between a reference sample and a sample contaminated by DOP in gaseous phase.

function of peak fluence. The irradiation tests performed on bare polished fused silica contaminated in gaseous phase presented in Fig. 3 show damage density for one of the reference samples. The laser tests have been repeated many times with the same result, so we conclude that a few monolayers of DOP obtained by gaseous contamination on bare polished fused silica optics have little effect on the laser induced damage density at 351 nm. Next, liquid phase contamination is investigated since it seems to be possible to find DOP in liquid form in the LIL facility.

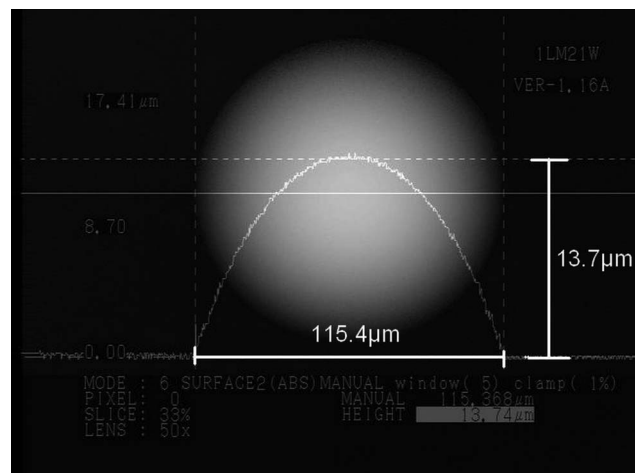
Fig. 4. Typical image of a DOP droplet on fused polished silica optics measured with a Lasertec 1LM21WD optical profilometer (top view and side view superposed— x and y scales are different).

contaminant is set down; then the sample goes on turning at 1500 revolutions per minute during 60 seconds to spread out the liquid. Contaminated samples were observed by optical microscopy with a Leica DMLM equipped with a 20 \times objective lens in normal incidence. This observation revealed the presence of droplets from a few microns to a few hundred microns radially spread onto the optics. Droplets shapes were measured on a Lasertec 1LM21WD optical profilometer. This device uses a He-Ne laser beam (633 nm), normal to the surface to be observed, and for the 50 \times objective, the lateral and vertical resolutions are 300 nm and 100 nm, respectively. A typical image of a droplet is shown in Fig. 4; the shape is close to a portion of sphere.

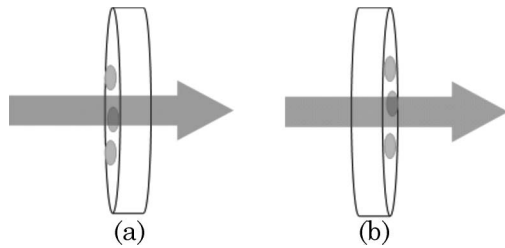
Fig. 5. Laser irradiation configurations: (a) droplets placed on input surface, (b) droplets placed on output surface.

The contaminated samples were laser tested with a raster scan procedure [16]. Two configurations were tested where droplets were placed on the input or on the output surface as shown in Fig. 5.

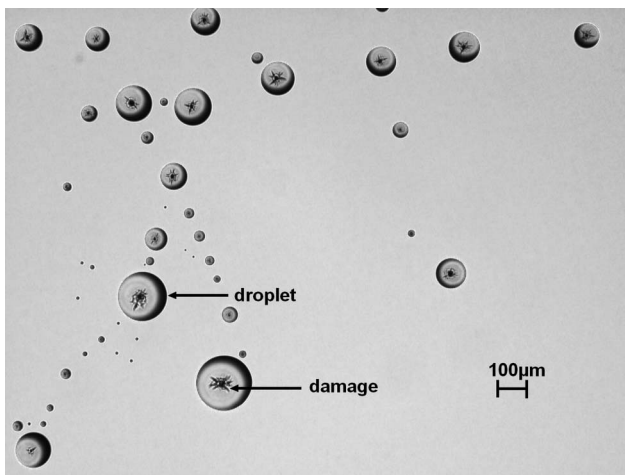
Fig. 6. Polished fused silica polluted by spin coating and raster scan irradiated with droplets on the output surface. A Leica DMLM optical microscope was used.

Figure 6 shows systematic damage under the droplets. The damage appeared for droplets larger than approximately 10 μ m, at 1 J/cm² for the front surface irradiation configuration and 4 J/cm² for the output surface irradiation configuration. After liquid phase

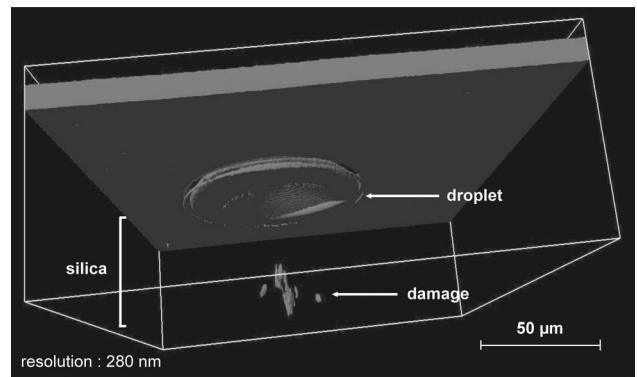
Fig. 7. Confocal microscopy image of a damage generated by droplet on silica.

The damage sites are situated in the bulk of the samples and centered under the droplets. Because of the position of these damage sites, confocal microscopy was used to give an overview of both the droplet and the damage after irradiation. Confocal images are acquired on a Leica DMR TCS SP2 microscope at normal incidence. The following experimental conditions were used: 20× objective, 458 nm wavelength laser normal to the surface to be observed, lateral resolution of 280 nm, and vertical resolution of 770 nm. An example of such an acquisition is given in Fig. 7. Confocal microscopy gives the measurement of the damage depth. Nevertheless, for more simplicity and rapidity, damage depths were evaluated by optical microscopy with a Leica DMLM microscope. Vertical resolution of this microscope is

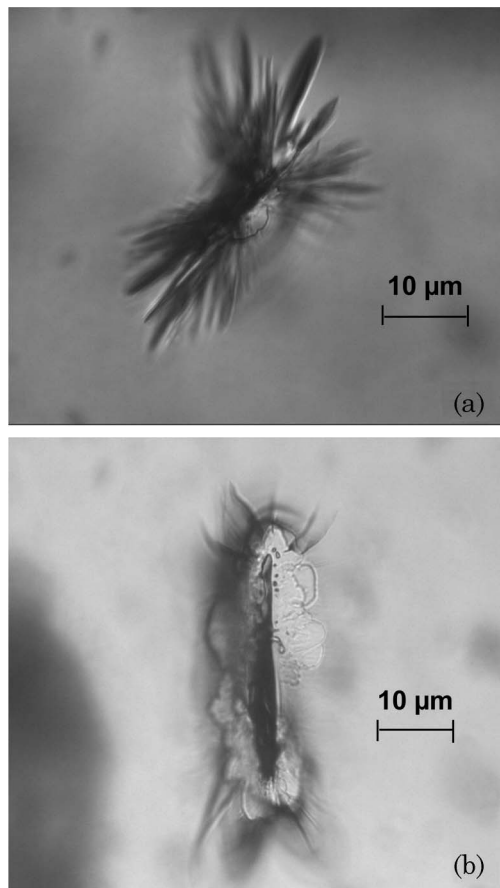
Fig. 9. Typical morphology of bulk damage after polishing: (a) top view, (b) side view.

To get a better understanding of the damage process, some samples were slowly polished on a Logitech PM5 machine until the bulk damage came to the surface. Side and top views of a typical damage crater can be seen in Fig. 9. Damage craters were seen to consist of a solidified previously molten region surrounded by a near concentric region of fractured material as shown in Fig. 9(a). This damage morphology is in good concordance with results from Wong [17]. In order to identify the nature of the damaged material, x-ray photoelectron spectroscopy (XPS) analysis was done on a bulk damage site revealed by polishing and on an undamaged zone

Considering that the position of the damage site was always associated with a droplet, we suspected a droplet micro-lensing effect, inducing a local increase of power density. The damage morphology in Fig. 9(b) seems to be in accordance with this hypothesis as it takes the shape of the laser beam geometrical caustic. Droplets were considered to be spherical. Since DOP has a refractive index, n , close to the index of fused silica ($n = 1.48$ at the wavelength $\lambda = 351$ nm), we considered two cases associated with the two irradiation configurations presented in Fig. 5. Droplets on the input surface were taken as equivalent to spherical diopters with a transmission coefficient of 96%. Droplets placed on output surfaces were considered as spherical mirrors with a reflection coefficient of 4%. We calculated Fresnel diffraction by a circular aperture of the focused beam including the effects of aberration. This can be written in the following form in the Fresnel approximation:

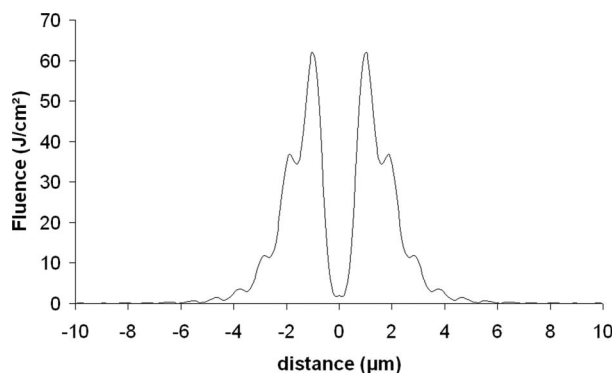
Fig. 11. Cross section of fluence profile of laser beam propagated after a $17.5 \mu\text{m}$ radius and $3.3 \mu\text{m}$ thick droplet with a paraxial focus of $150.6 \mu\text{m}$ at the damage position $121.6 \mu\text{m}$.

Fig. 11. Calculated maximum fluences are between 35 J/cm^2 and 100 J/cm^2 for all the damage sites positions and for both irradiation configurations. We compared these values with bulk SiO_2 laser induced damage threshold data. Kuzuu [19] reported a laser damage threshold of 20 J/cm^2 at 355 nm and 0.85 ns on synthetic fused silica. This value is equivalent to 37 J/cm^2 at 2.5 ns using a $\tau^{0.5}$ scaling law [20]. Consequently, calculated maximum fluences are greater than the real bulk damage threshold measured in fused silica, demonstrating that the micro-lens focalization mechanism can explain the damage observed.
