# R&D Activities on RF Contacts for the ITER Ion Cyclotron Resonance Heating Launcher

Keywords: ICRH, RF Contacts, ITER

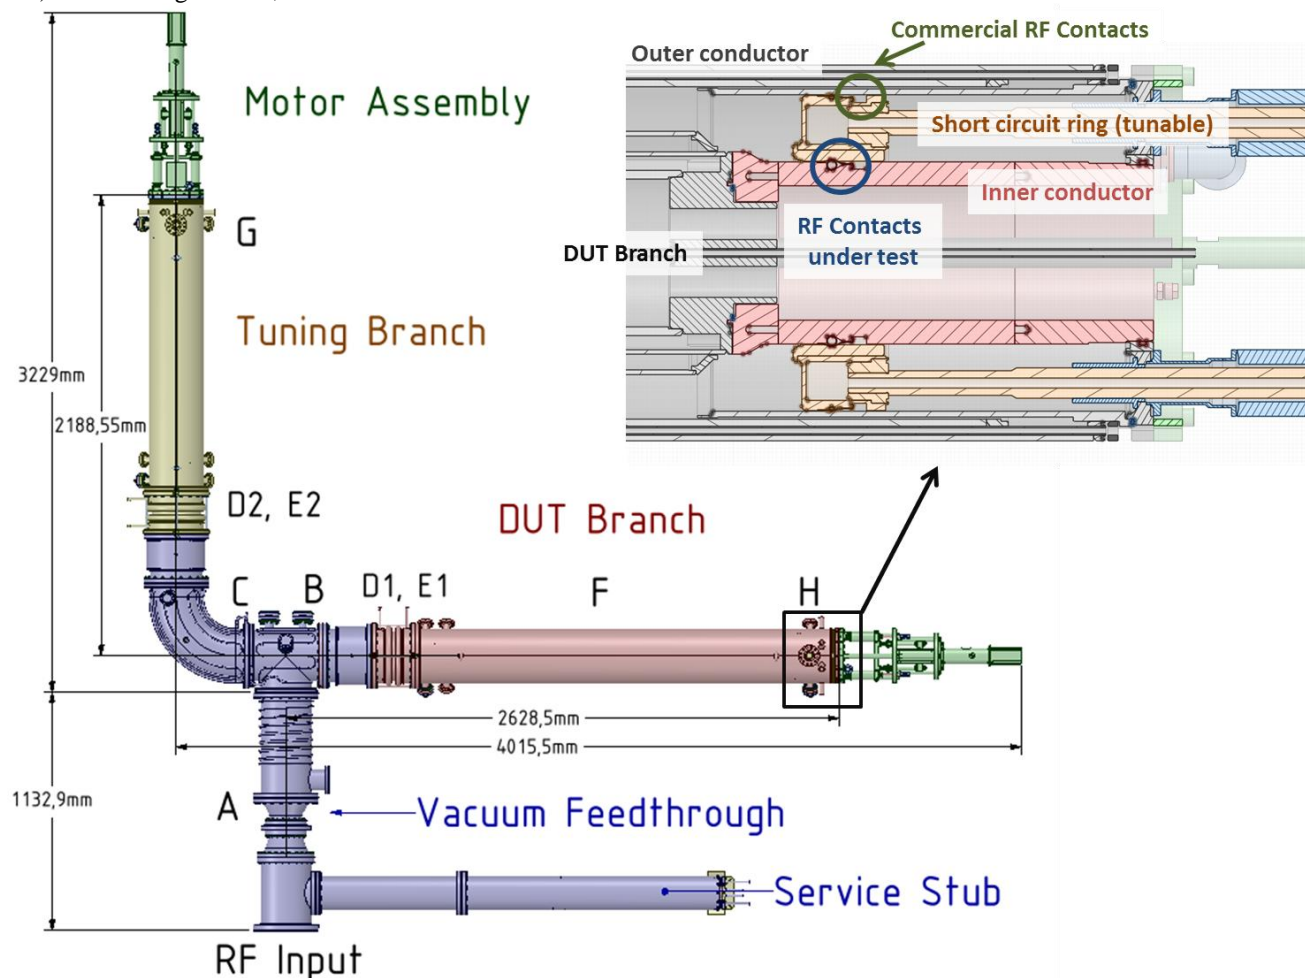
Fig. 1 shows the T-resonator geometry. The RF contacts under test are located in the Device Under Test (DUT) branch, which has been designed in order to maximize the current level at the short-circuit side, in contrast to the tuning branch. The resonator is connected to the RF generator which can deliver a few hundred kilowatts to achieve up to 2.5 kA in the DUT branch and 45 kV in the tuning branch [7]. One of the main challenges of the RF contacts development is their qualification in steady-state conditions. The inner and the outer conductor of the resonator are thus actively cooled with water. The RF contact to be tested is assembled on a sliding trolley, actively cooled by the

Fig. 1. T-Resonator description and overall dimensions. Letters indicate the locations of thermocouples.

TITAN hot water loop to mimic the  $\sim 90^{\circ}\text{C}$  operating temperature in ITER conditions. In order to test the contacts with a 20% safety margin, the required current on the contacts under test is 2.25 kA (with the worst current density case), pressure below  $10^{-3}\text{Pa}$ , at 62 MHz in order to maximize the current losses and thermal dissipation and during quasi steady-state pulses (20 to 30 minutes). The tuning branch, in which current is 60%

less than DUT branch current, is also ended with a sliding trolley, equipped with commercial Multi-Contact<sup>TM</sup> contacts. Motor assemblies on both sides of the resonator are used to remotely tune both short-circuit positions from the control room and to make short displacements mimicking the relative thermal displacements within the antenna during RF pulses.
