# R&D Activities on RF Contacts for the ITER Ion Cyclotron Resonance Heating Launcher

Keywords: ICRH, RF Contacts, ITER

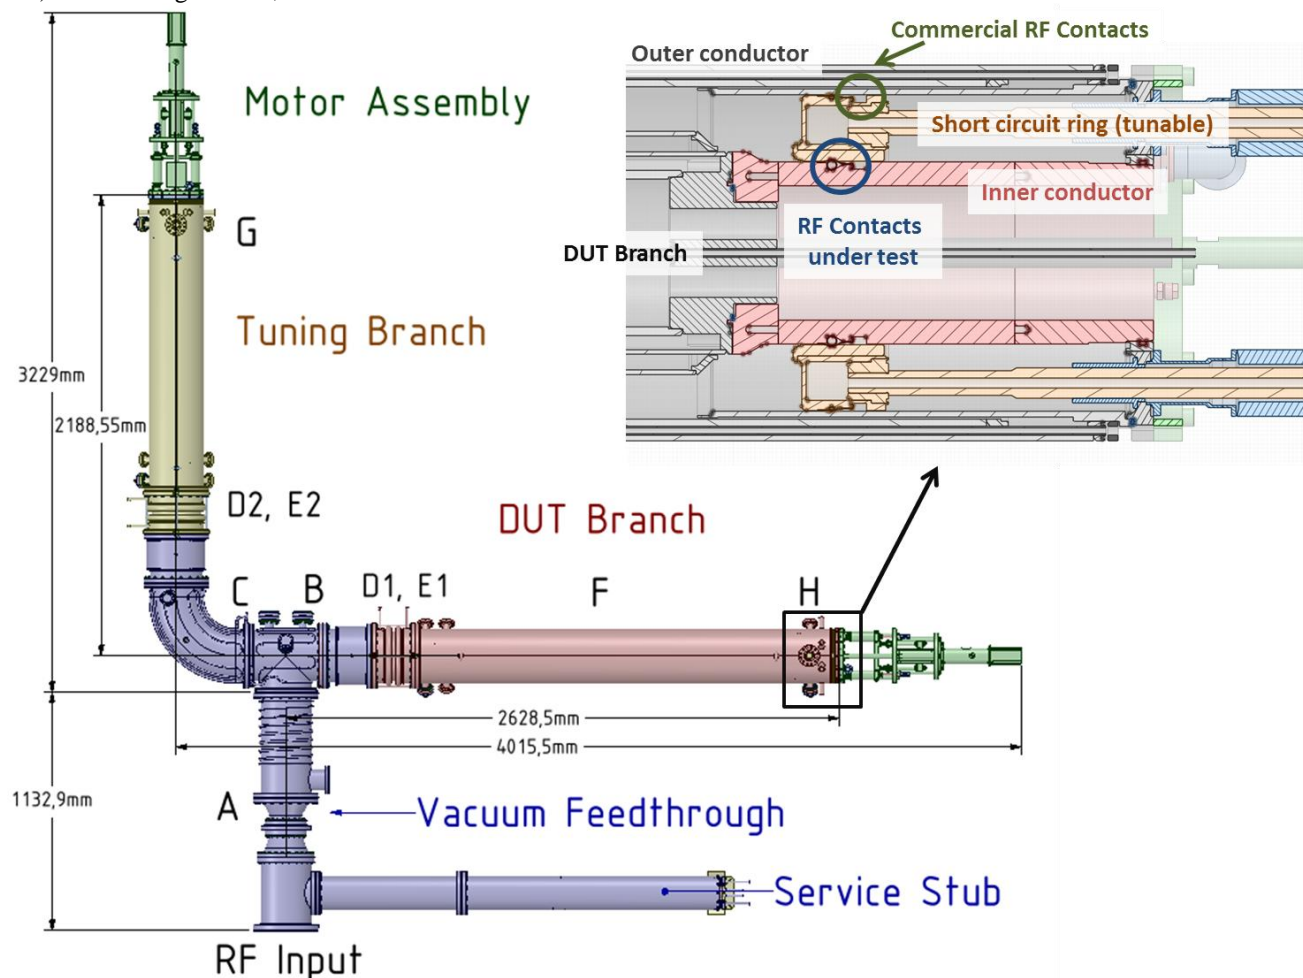
Fig. 1. T-Resonator description and overall dimensions. Letters indicate the locations of thermocouples.

Fig. 1 shows the T-resonator geometry. The RF contacts under test are located in the Device Under Test (DUT) branch, which has been designed in order to maximize the current level at the short-circuit side, in contrast to the tuning branch. The resonator is connected to the RF generator which can deliver a few hundred kilowatts to achieve up to 2.5 kA in the DUT branch and 45 kV in the tuning branch [7]. One of the main challenges of the RF contacts development is their qualification in steady-state conditions. The inner and the outer conductor of the resonator are thus actively cooled with water. The RF contact to be tested is assembled on a sliding trolley, actively cooled by the

less than DUT branch current, is also ended with a sliding trolley, equipped with commercial Multi-Contact<sup>TM</sup> contacts. Motor assemblies on both sides of the resonator are used to remotely tune both short-circuit positions from the control room and to make short displacements mimicking the relative thermal displacements within the antenna during RF pulses.

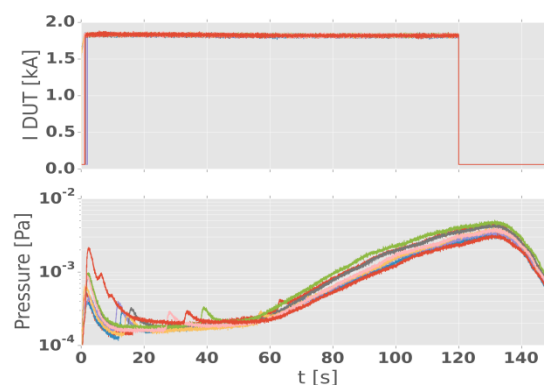
Fig.2. Illustration of the 8 consecutive trials of 1.8kA/120s pulses (traces superposed). For all pulses, the pressure is increasing after 50-60s of RF power, indicating an out-gassing component.

reflected power). Start of power RF pulses. (6) Decrease/Increase of hot water temperature for tests purposes. (7) The best RF pulses achieved (from the test stand point of view) were 2480 A/50 ms (corresponding to 2250 A + 10% margin) and 1470 A/1000 s. Out-gassing is very low during discharge (see close up illustrations below). (8) Best RF pulse achieved: 1700 A/1200 s. Following these pulses, large out-gassings have been monitored for higher currents, up to the interlock limit of  $10^{-2}$  Pa. Additional attempts have been performed at 1800 A/120 s, with reproducible out-gassings observed after 60 s of RF pulse, as illustrated in Fig.2. Ultimately after additional few attempts, RF power could not be sent in the resonator anymore. Finally RF shots have been performed with the resonator filled with nitrogen, and acoustic evidences of arcs have been heard.

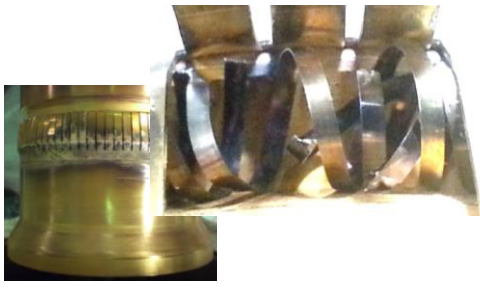
Fig.3. Close-up on the RF contact lamellas (left) and spring behind three lamellas (right). The diameter of the contacts band is 125 mm. The lamella width is 4 mm. The spring has melted in different locations (right).

Once disassembled, burn traces have been observed close to the lamellas of the DUT contacts (Fig.3), no other evidence of arcs were observed elsewhere on the RF structure. To investigate the defect, ultrasonic flaw detector was used on the contacts brazing and showed that the thickness under the brazed strip was not uniform, both in the axial direction (from the strip end to the lamellas) and in the angular direction (0-360°). Moreover, the burn traces are correlated to a local decrease of the thickness under the lamella. Since the detector couldn't be calibrated, no numerical value could be given. Post-mortem precise measurements of the brazing thickness are expected in a future work. This change of thickness could be interpreted as a flaw of brazing alloy under the material (probably due to small gaps). This hypothesis has been corroborated by a dye penetrant inspection, showing that local surface flaws were corresponding to local increase of the thickness measured with the ultrasonic flaw detector.

It is inferred that a degradation of the thermal contact between the lamellas and the core conductor, due to a deteriorated brazing layer or substances resulting from plating, could have locally increased the temperature, thus leading to out-gassing, to local arcing and a higher temperature increase up to the brazing material melting. It has to be noted that the spring has melted in various regions, indicating that its temperature abnormally increased locally. The cause of this melting is not known, but can be due to a fraction of the RF current flowing across the spring. Moreover, the region under the lamellas is badly pumped, and it is possible that out-gassing in this region had led to micro-plasma formation. Following this test, a novel design has been proposed that replaces the spring by folded stainless-steel lamellas. This configuration should improve the pumping behind the lamellas and its reliability.

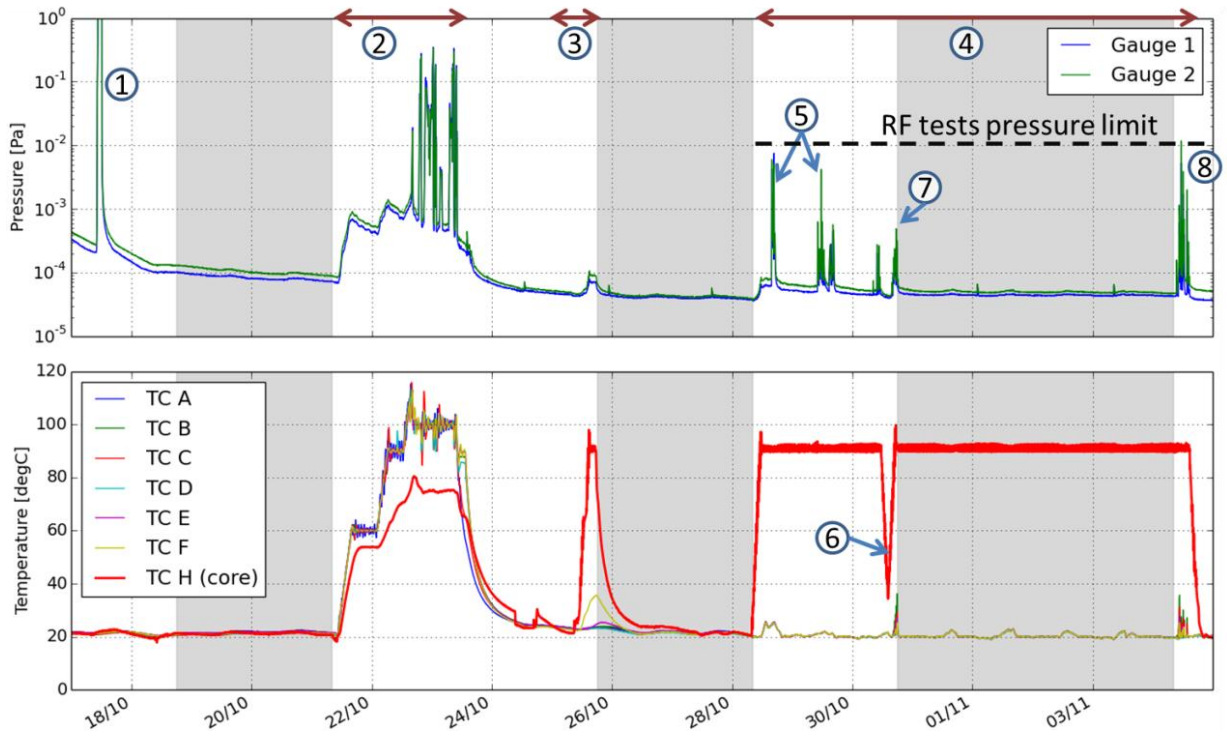
Fig.4. Timeline of the CCFE contacts RF test from 17/10 to 05/11/2013 from continuous data acquisition system. Thermocouple (TC) locations are illustrated by the letters in the Fig.1. TC H is located in the contacts core under test (inner conductor temperature).

The RF contacts described in the above section have been tested under RF in the CEA T-resonator test-bed. The test timeline is illustrated in Fig.4 and detailed below.

(1) Vacuum pump down. (2) Electrical baking up to 110°C, where abrupt rises of the pressure occurred when temperature reached 110°C. These sharp rises are assumed to be due to thermal dilatations which induce leakage on the assembly. (3) Test of the 90°C hot water loop connected to the contacts. (4) The 90°C Hot water loop is on. (5) The pressure is below  $10^{-4}$  Pa ( $8 \cdot 10^{-5}$  Pa) and RF conditioning begins (series of short RF pulses on un-matched resonator). First successful RF conditioning on matched configuration obtained (no
