## Quench Behavior Of Sic/Sic Cladding After High Temperature Ramp Under Steam Conditions

## **QUENCH BEHAVIOR OF SiC/SiC CLADDING AFTER A HIGH TEMPERATURE RAMP UNDER STEAM CONDITIONS**

**KEYWORDS:** *Silicon carbide, SiC/SiC composite, Accident Tolerant Fuel, quench, oxidation.*

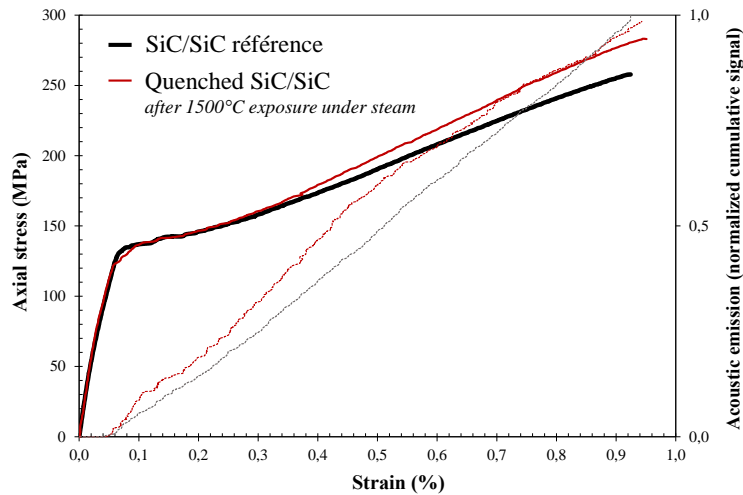
Thermal shocked specimens were tested up to failure in tensile loading after quenching to investigate the residual mechanical performances (in accordance with ISO 20323 [17]). As shown in Fig. 3, the damage induced by the thermal shock did not significantly impact the mechanical behavior which exhibits a typical “non-linear elastic damageable” curve of CVI-SiC/SiC tubes. Young modulus (EP), yield strength ( $\sigma_Y$ ) and strain at ultimate failure ( $\epsilon_m$ ) remain unchanged in comparison to the composite reference properties (see Table 1). Better yet, quenched tubes tended to induce higher tensile strength which could result from an increase of the matrix strength. Such an observation suggests a surface crack healing related to silica formation under steam. Similar effects could also be induced by a reduction of the Weibull’s modulus characterized by a scatter in strength data. Thus, the matrix cracks would be formed at increasing stress levels as reflected by the measured non-linear domain of deformation. An associated mechanical behavior was already modeled on SiC/SiC minicomposites by Lissart et al [18]. Whether the specimens were quenched or not, only a single regime of acoustic emission was detected indicating that matrix cracking saturation did not occur up to the ultimate failure.

Fig. 3. Tensile stress-strain mechanical behavior of quenched SiC/SiC tube after 1500°C exposure under steam for 100s. Also given for comparison is the reference stress-strain curve measured on as-fabricated SiC/SiC tube.

Young modulus $EP$ (GPa)	Yield strength $\sigma_Y$ (MPa)	Tensile strength $\sigma_m$ (MPa)	Strain at ultimate failure $\epsilon_m$ (%)
SiC/SiC Reference (averaged over 3 tubes)	$285 \pm 3$	$97 \pm 6$	$252 \pm 8$	$0.95 \pm 0.03$
Quenched SiC/SiC after 1500°C exposure under steam	280	104	283	0.95
